Bottle Tree, Main Street, Alstonville

Prepared by Integral Tree Care for Ballina Shire Council

### Arborist report on Brachychiton rupestris for Ballina Shire Council 16th of December 2017

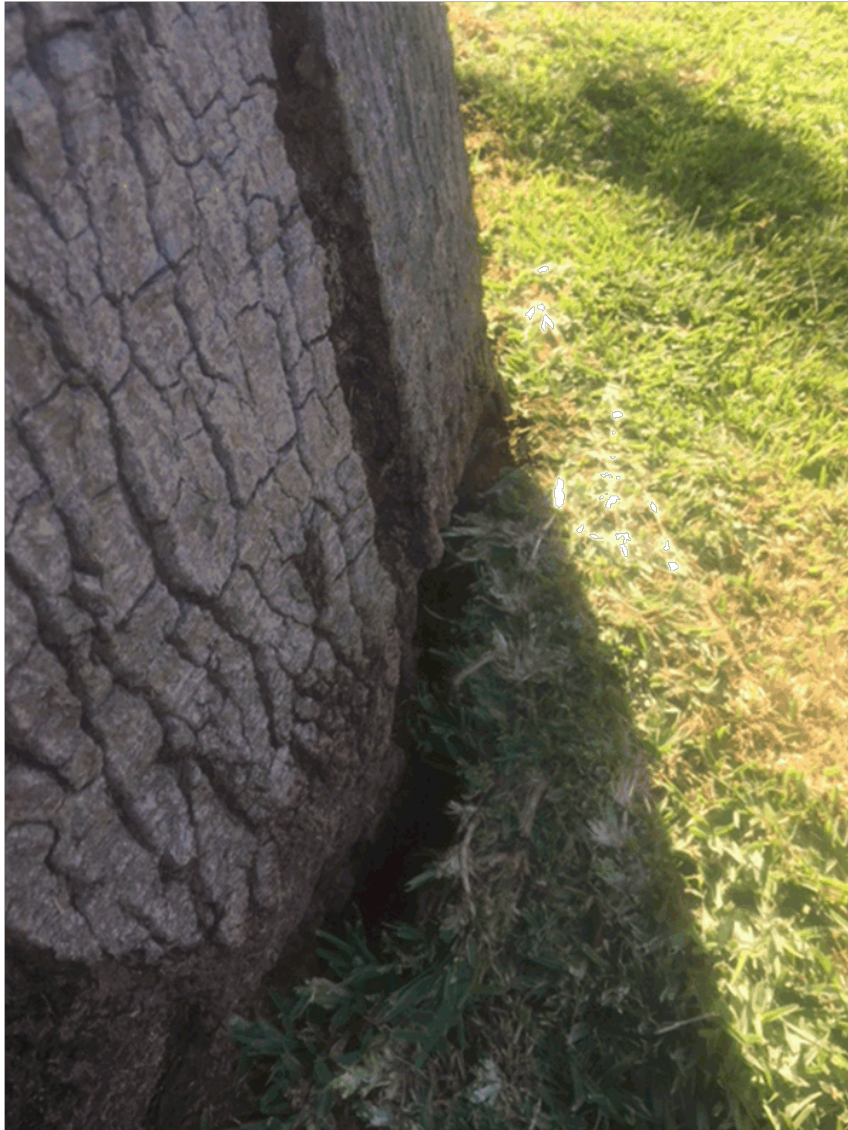
Roots – Recent work to footpath has cut roots and undermined tree on southern side of tree. The northern side of the roots are heaving the ground. Normal ground level mark on trunk now about 50 mm above ground level. (See Photo 1)

The QTRA Risk of harm is 0.04 (High) due to a combination of the partial failure in the root crown, its lean over the foot path and the usage of the foot path. The footpath is a regular route used daily by children to and from school.

The damage to the trees' root crown was affecting its' structural stability so severely that it led to the primary failure of the tree. Once tree failure like in this case is initiated complete failure is typically seen in the near future with the risk of contact with a target being intolerable to the tree owner.

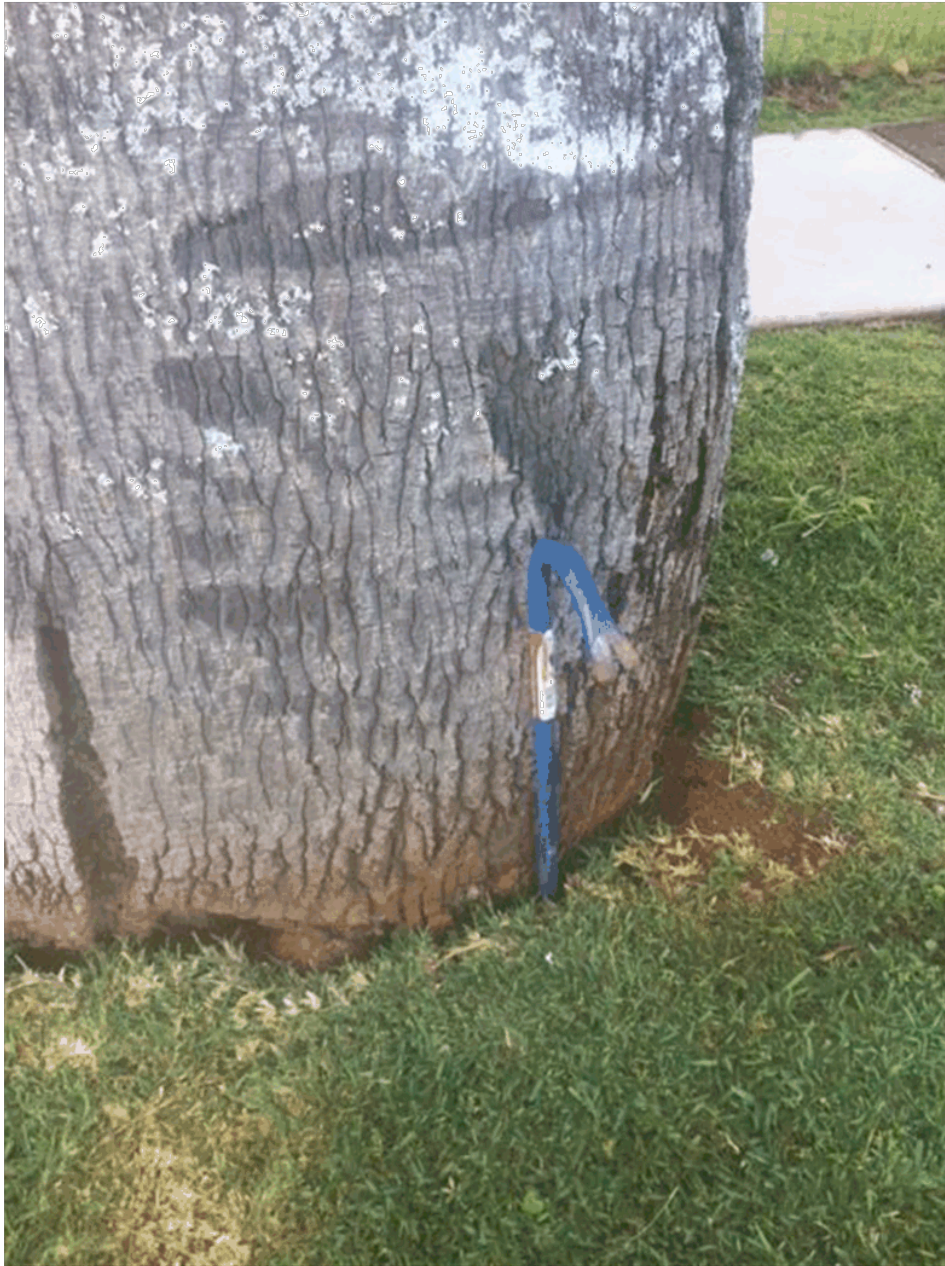
Trunk/s – On 15 % lean. (See Photo 2)

Crown/Branches – Moderate. Dieback through southern part of crown. (See Photo 2)
