BALLINA SHIRE COUNCIL

**GEOTECHNICAL REPORT ON LANDSLIDE
REMEDICATION
COAST ROAD, LENNOX HEAD**

10644/1-C
July 2011

RE: LANDSLIDE REMEDIATION, COAST ROAD, LENNOX HEAD

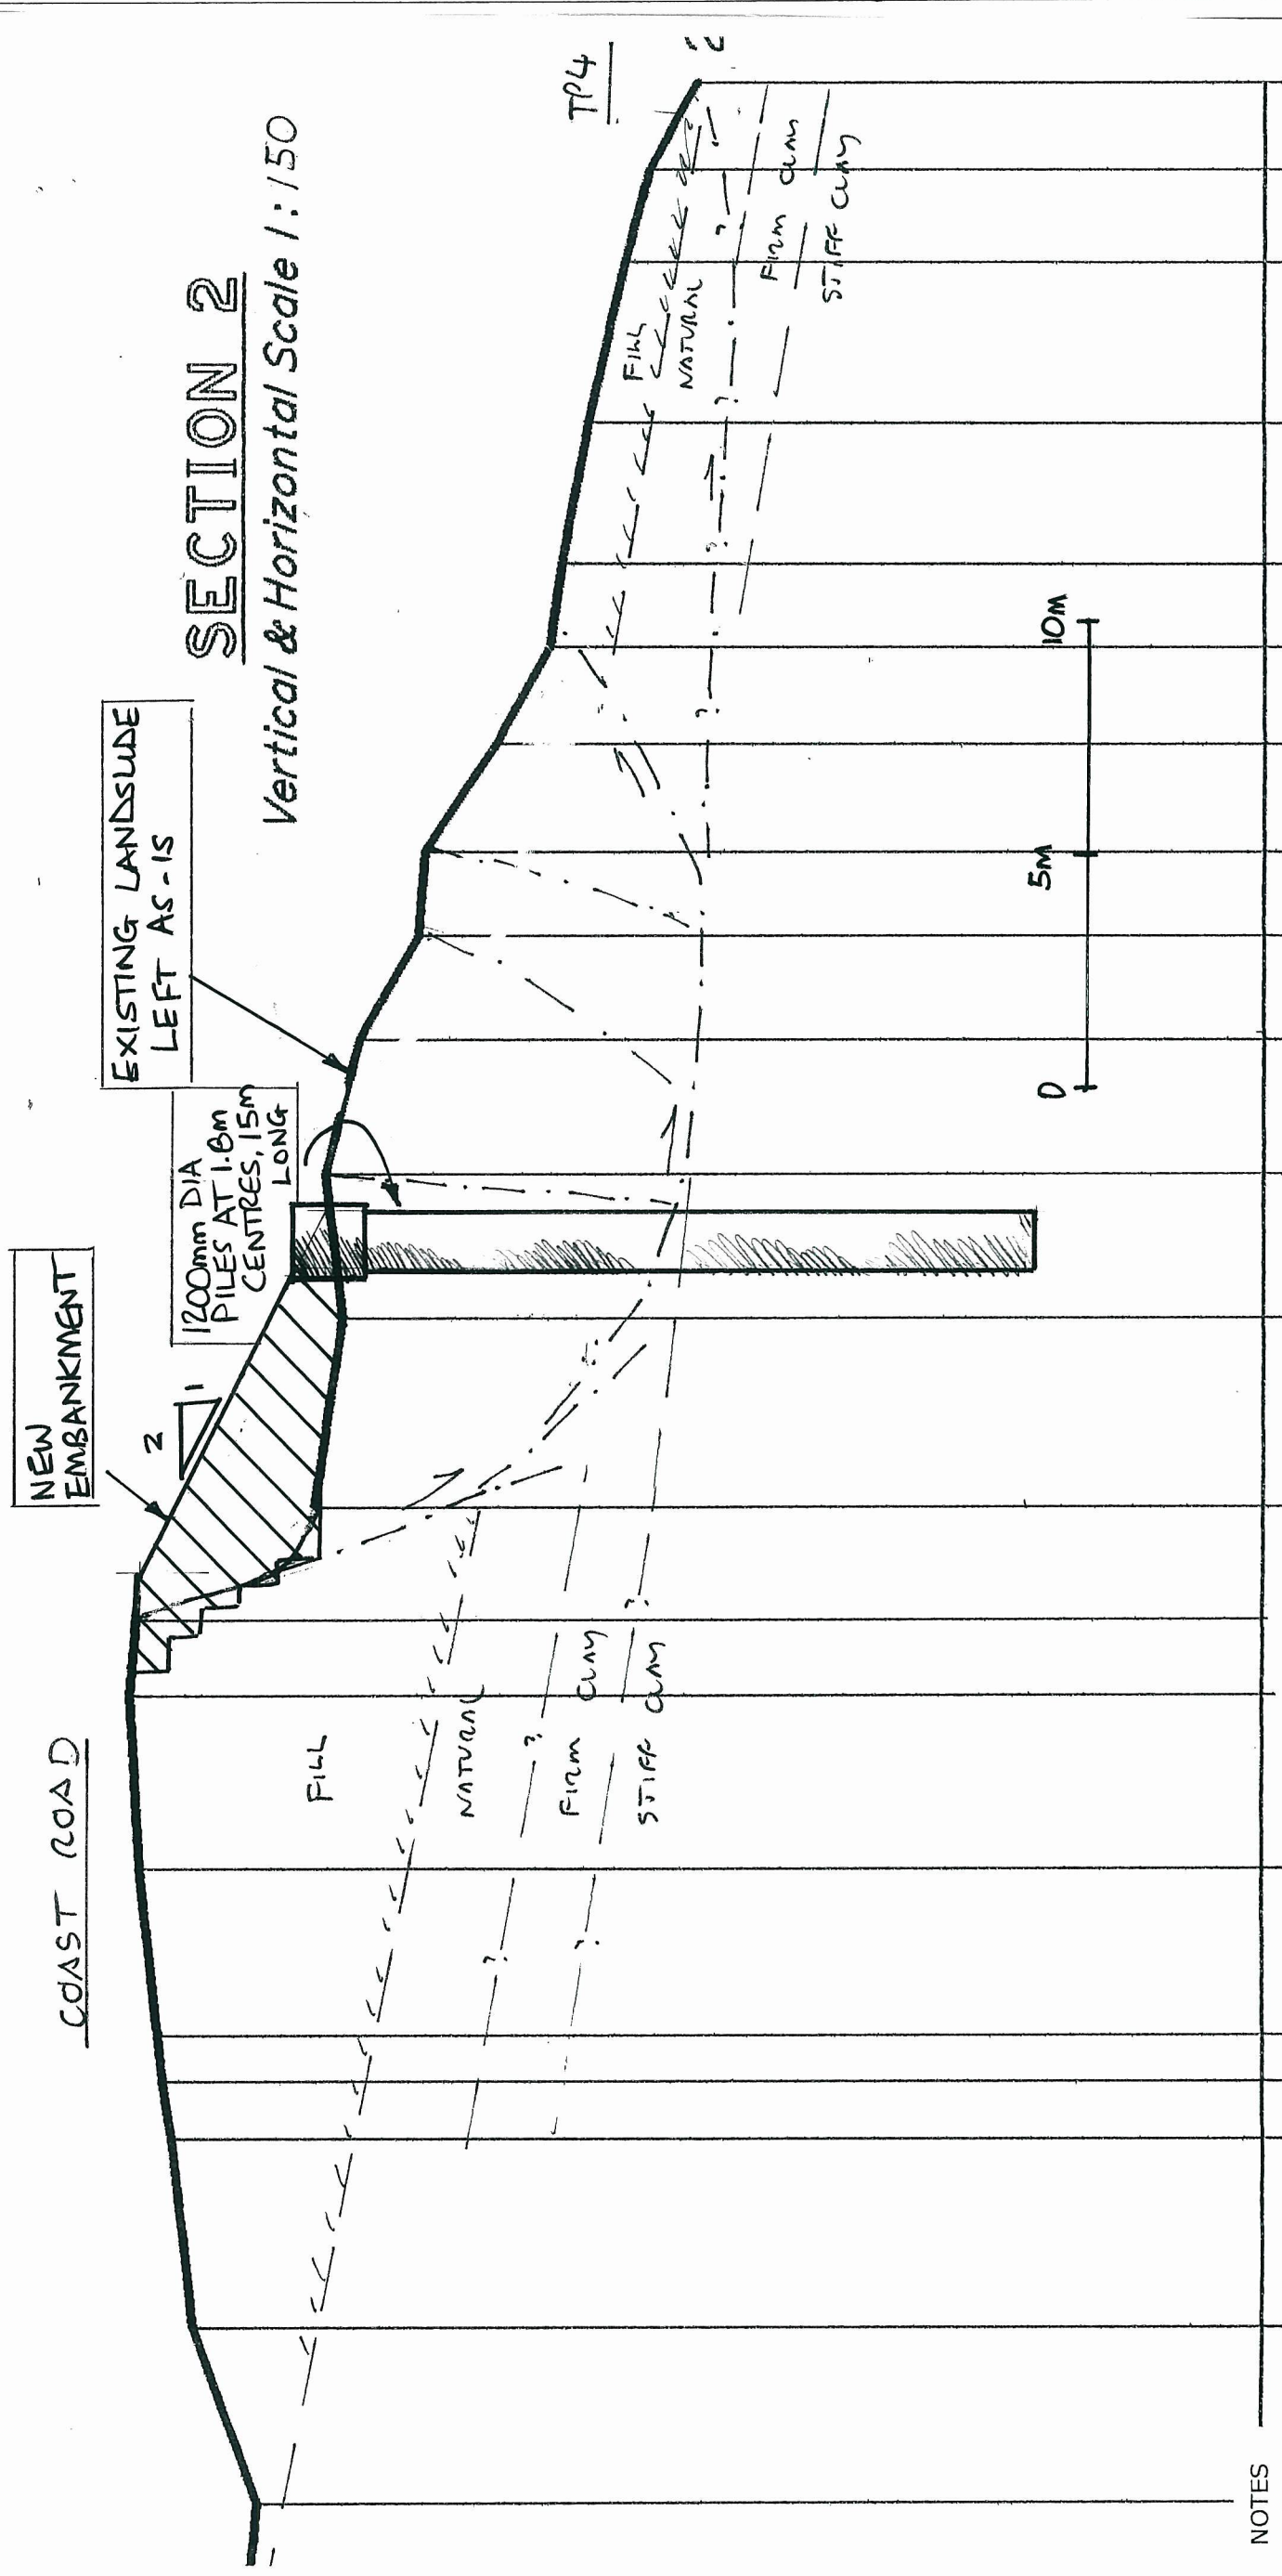
Drawn By: ps	BALLINA SHIRE COUNCIL COAST ROAD LANDSLIDE REMEDIATION INDICATIVE PILED RETENTION AT CREST OF EXISTING EMBANKMENT WITHIN LANDSLIDE AREA	Figure 7
Approved by:		
Date: April 2011		
Scale: 1:150

The options involve leaving the landslide debris in place and supporting the existing batter using bored piles at the crest of the existing road embankment (Figure 7) or supporting a reconstructed batter using bored piles on the existing footpath alignment (Figure 8). Only a preliminary design has been carried out at this stage and further detailed analyses would be required, along with the involvement of a specialist piling contractor if these options are to be considered further.

Preliminary design indicates that for the option shown on Figure 7, 20m long, 1200mm diameter piles at 1.8m centres will provide an adequate factor of safety. Lateral deflections at the pile head are estimated to be in the order of 80mm. The piles would be installed from the existing road embankment and for in-service use would require the road to be moved towards the hillside to provide sufficient width for a road shoulder. It is assumed that road crash barriers could be constructed within the capping beam. It will also be necessary to construct shotcrete or panel facing on the upstand section of the piles to bridge the gaps between the piles and support the soil.

These options are shown in schematically on Figures 7 and 8 and been considered to minimise work within the landslide area. The pedestrian access path would need to be permanently closed unless further works were carried out to stabilise the landslide area.

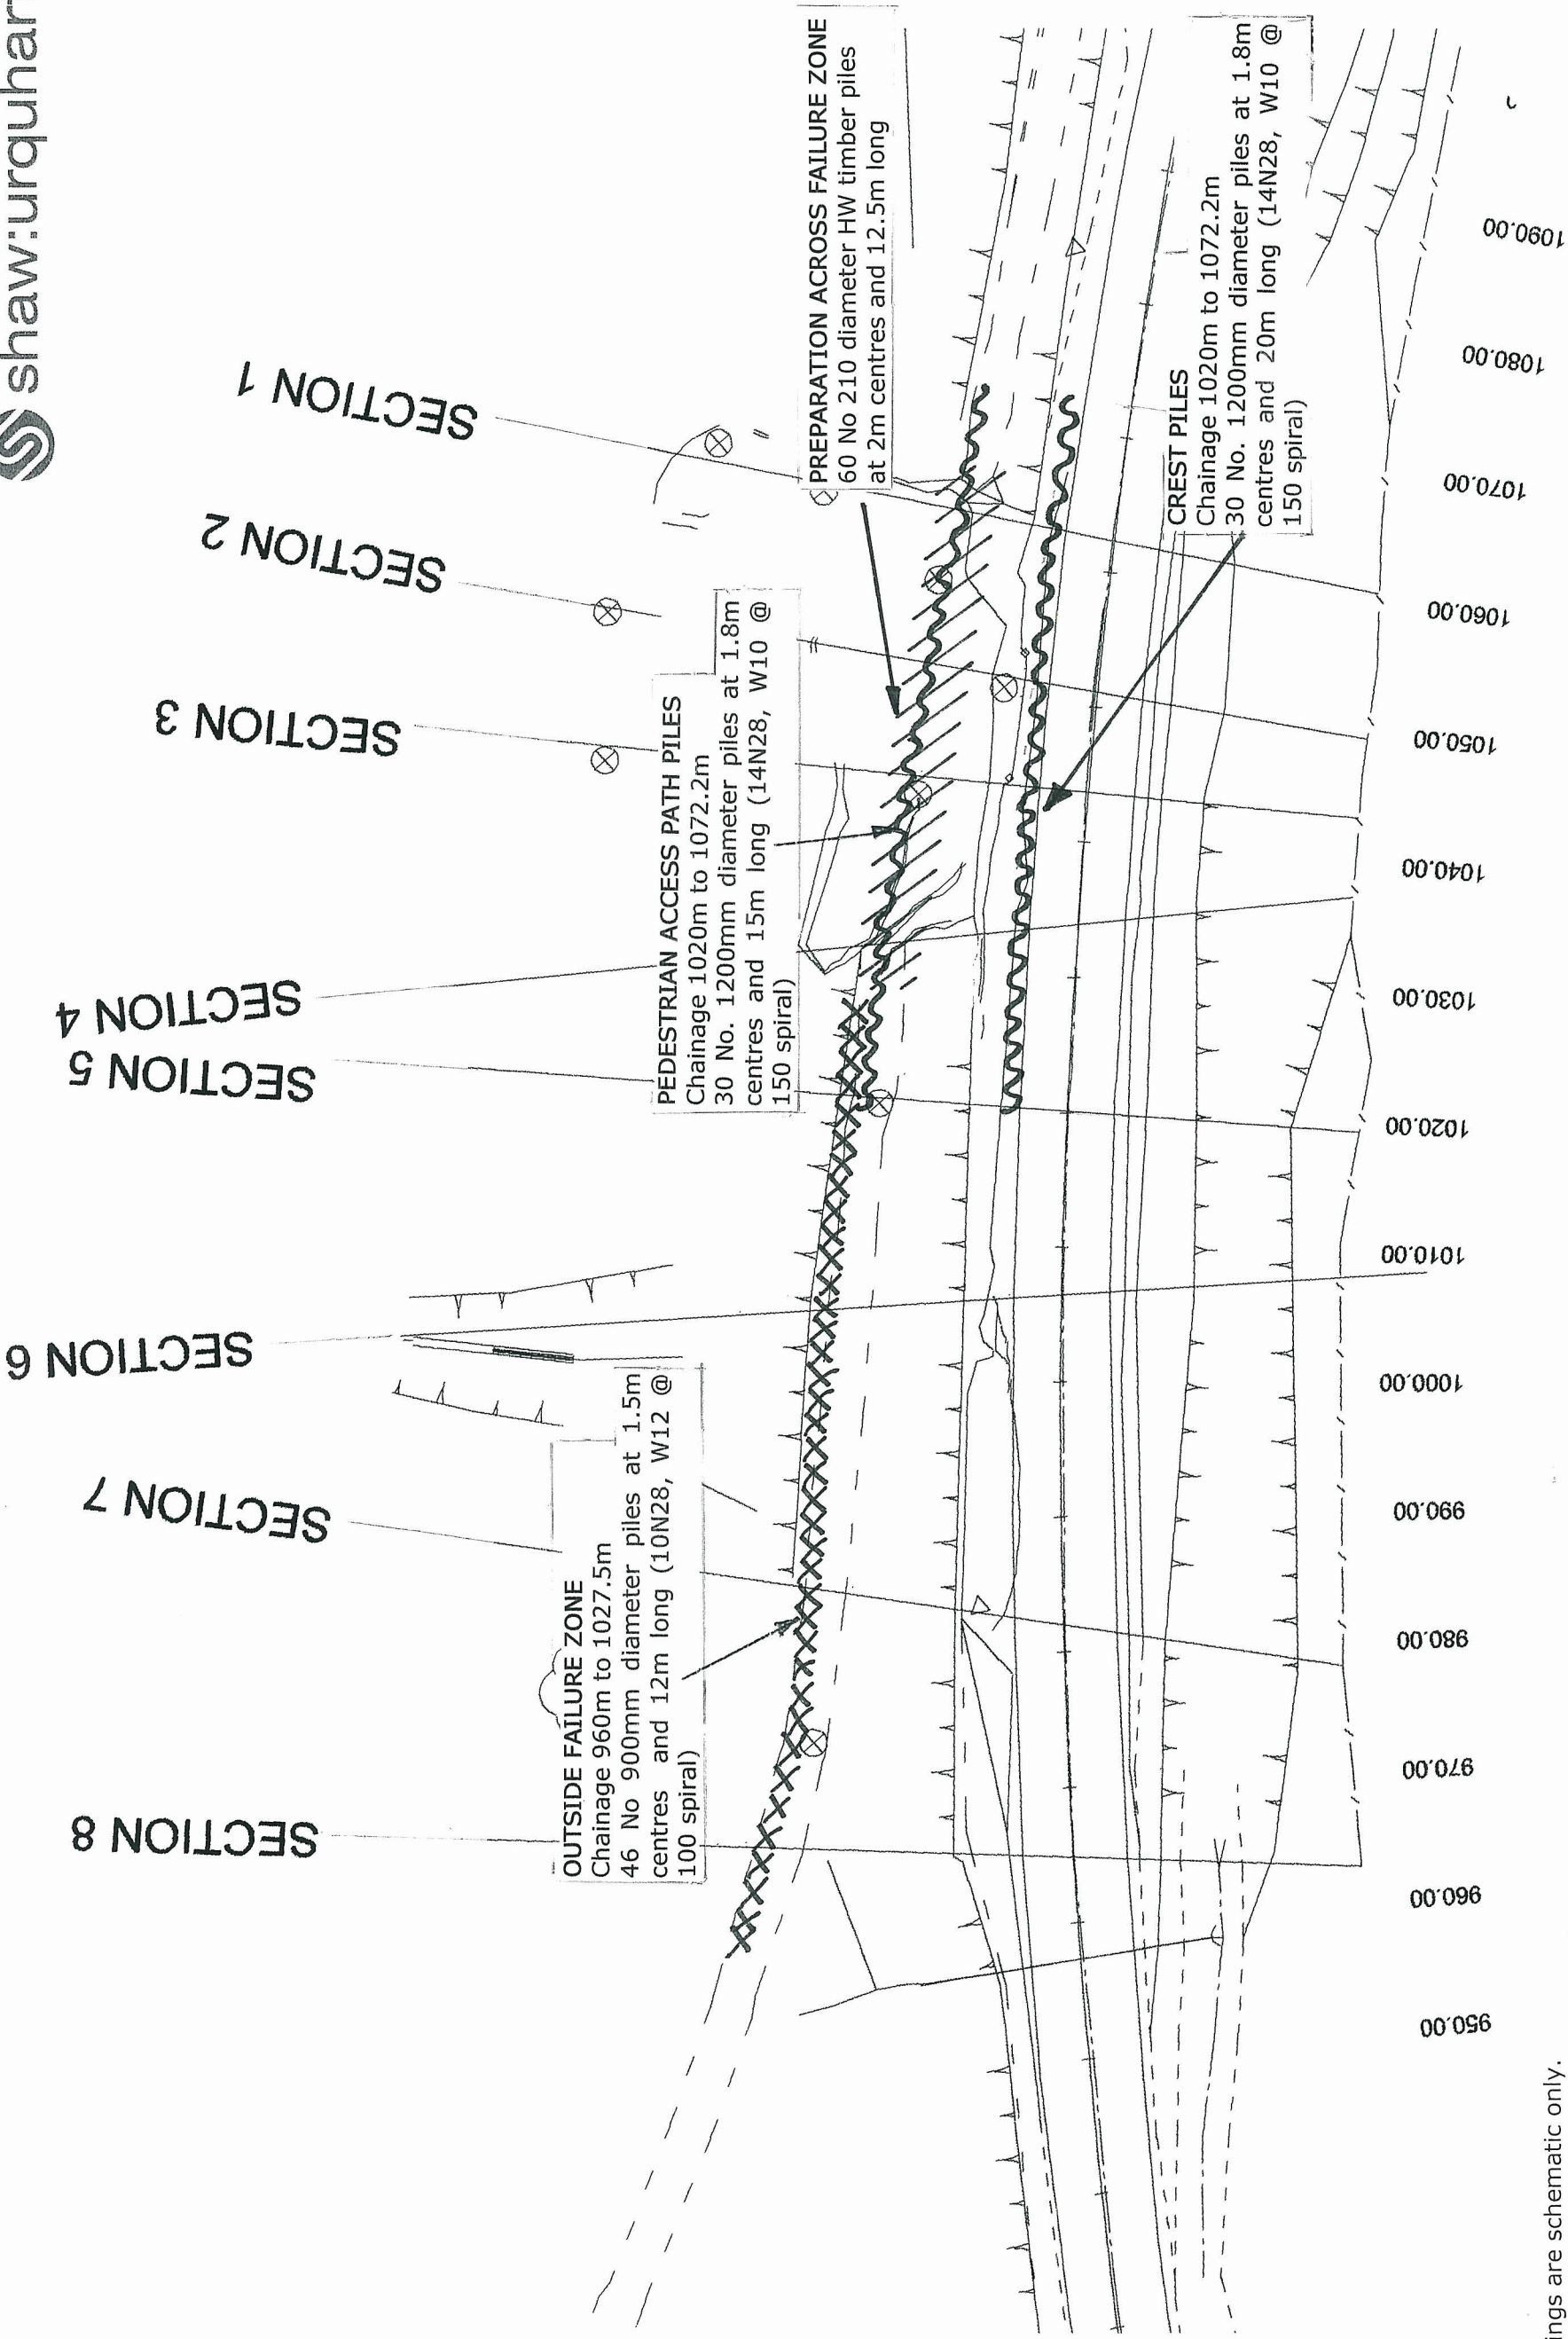
Figure 12
 Job No.: 10644/1

The approximate extent of the various earthworks options is shown in plan view on Figure 12 along with the piling options.

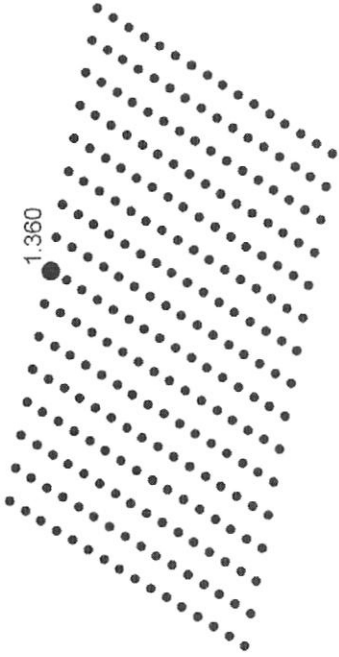
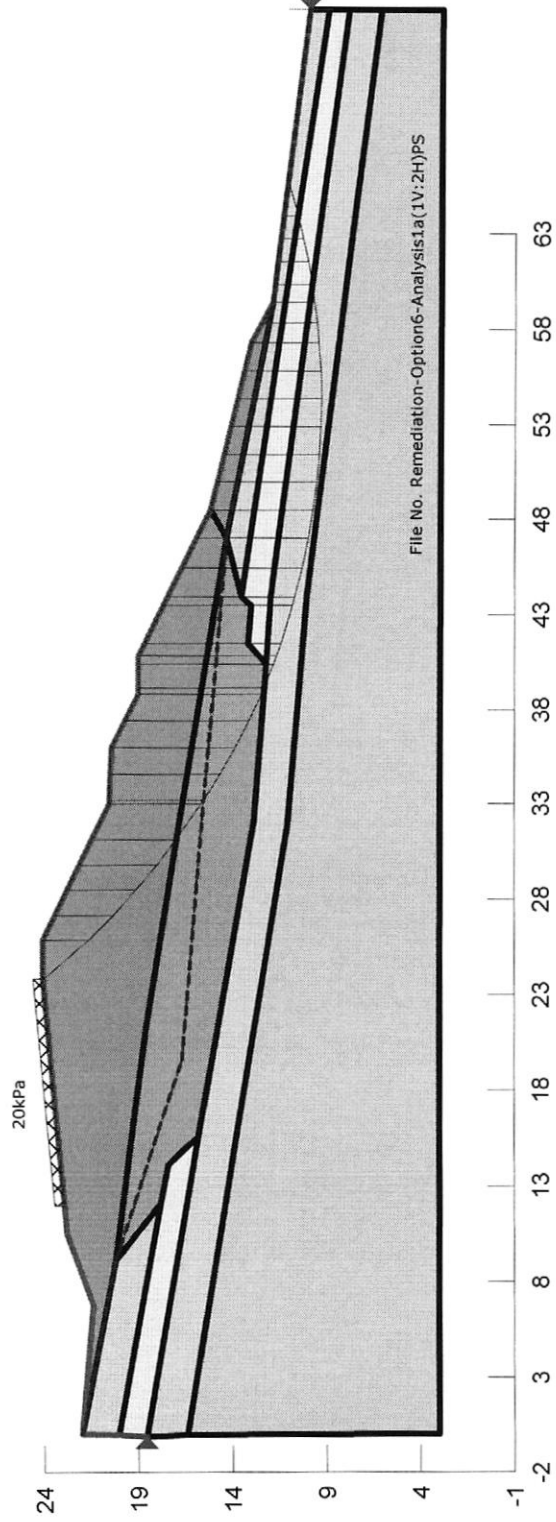
10644/1
 Ballina Shire Council
 Landslip Remediation, Coast Road, Lennox Head
 Section 2, BH1/TP7/TP3 Soil Profile, Post Failure
 Raised Groundwater Level with Toe Drains
 Re-Profiled Batter, Clay Fill Replacement

- Description: Clay Fill
 Wt: 20
 Cohesion: 5
 Phi: 27
- Description: Silty Clay, F
 Wt: 18
 Cohesion: 3
 Phi: 25
- Description: Silty Clay, St-VSt
 Wt: 18
 Cohesion: 8
 Phi: 27
- Description: Silty Clay, St
 Wt: 18
 Cohesion: 5
 Phi: 25
- Description: Silty Clay, Reduced Strength
 Wt: 18
 Cohesion: 0
 Phi: 11
- Description: Base Clay Fill
 Wt: 20
 Cohesion: 5
 Phi: 25

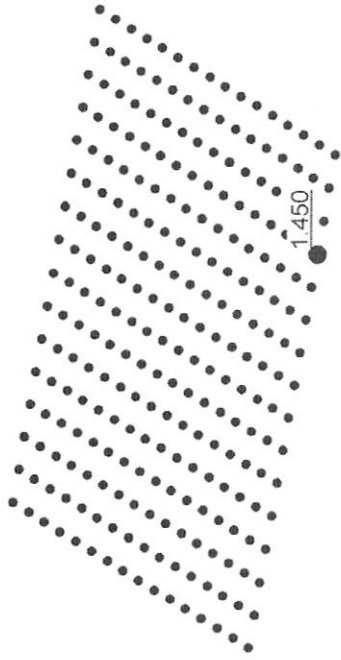
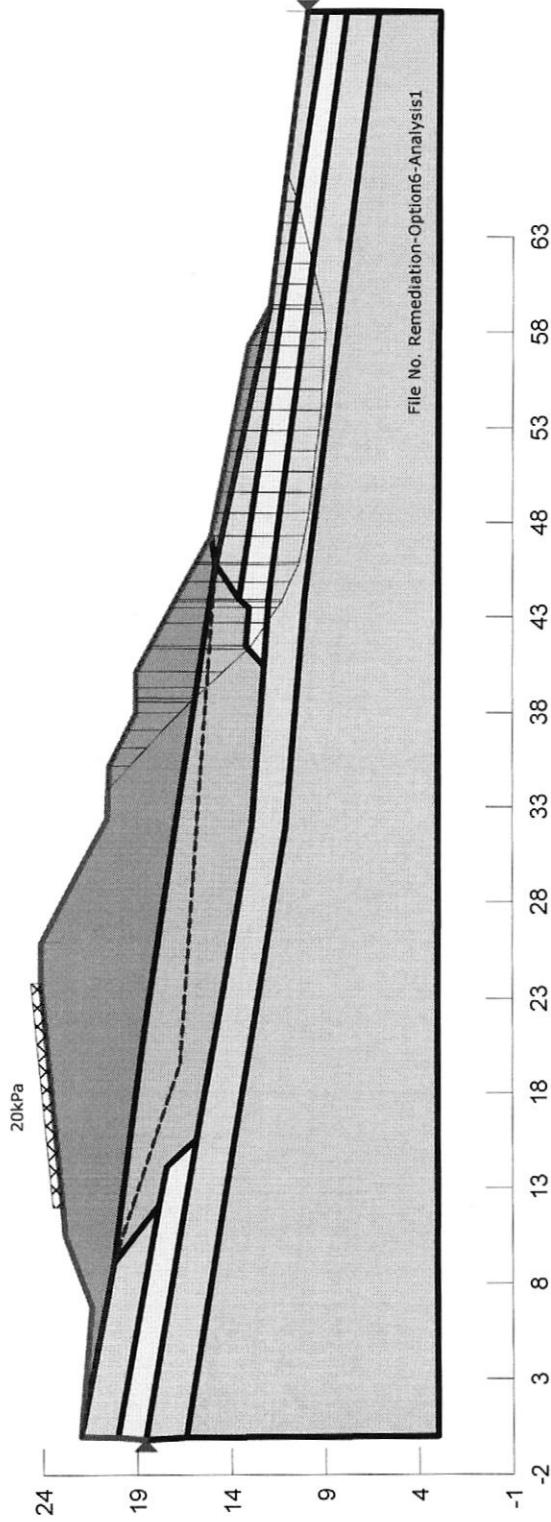
10644/1
 Ballina Shire Council
 Landslip Remediation, Coast Road, Lennox Head
 Section 2, BH1/TP7/TP3 Soil Profile, Post Failure
 Raised Groundwater Level with Toe Drains
 Re-Profiled Batter, Rock Fill Replacement of Firm Clay

- Description: Clay Fill
 Wt: 20
 Cohesion: 5
 Phi: 27
- Description: Silty Clay, F
 Wt: 18
 Cohesion: 3
 Phi: 25
- Description: Silty Clay, St-VSt
 Wt: 18
 Cohesion: 8
 Phi: 27
- Description: Silty Clay, St
 Wt: 18
 Cohesion: 5
 Phi: 25
- Description: Silty Clay, Reduced Strengl
 Wt: 18
 Cohesion: 0
 Phi: 11
- Description: Rock Fill
 Wt: 20
 Cohesion: 0
 Phi: 45

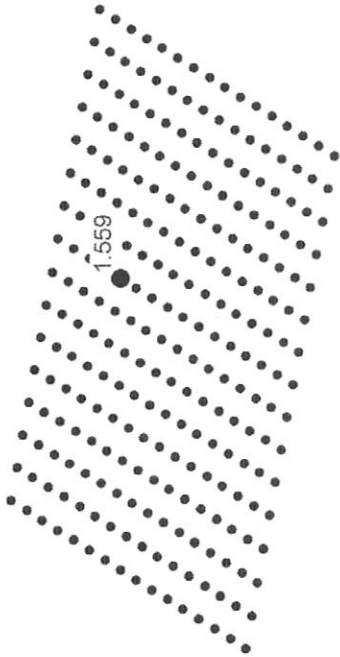
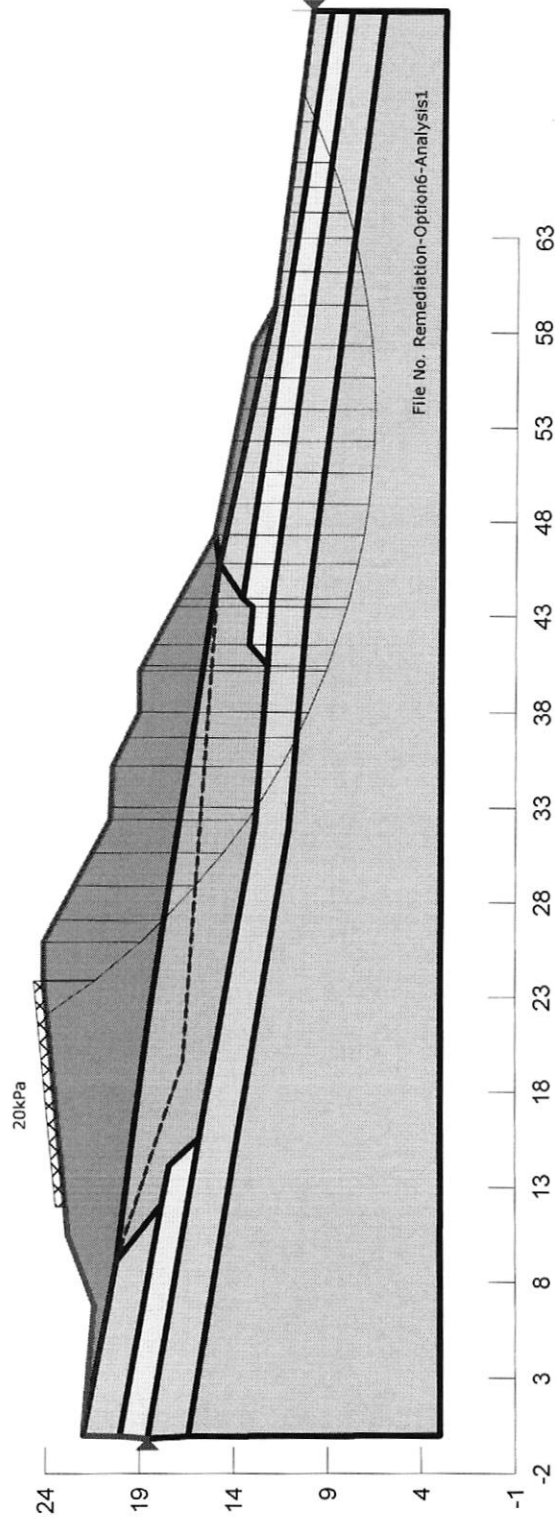
10644/1
 Ballina Shire Council
 Landslip Remediation, Coast Road, Lennox Head
 Section 2, BH1/TP7/TP3 Soil Profile, Post Failure
 Raised Groundwater Level with Toe Drains
 Re-Profiled Batter, Rock Fill Replacement of Firm Clay

- Description: Clay Fill
 Wt: 20
 Cohesion: 5
 Phi: 27
- Description: Silty Clay, F
 Wt: 18
 Cohesion: 3
 Phi: 25
- Description: Silty Clay, St-VSt
 Wt: 18
 Cohesion: 8
 Phi: 27
- Description: Silty Clay, St
 Wt: 18
 Cohesion: 5
 Phi: 25
- Description: Silty Clay, Reduced Strength
 Wt: 18
 Cohesion: 0
 Phi: 11
- Description: Rock Fill
 Wt: 20
 Cohesion: 0
 Phi: 45

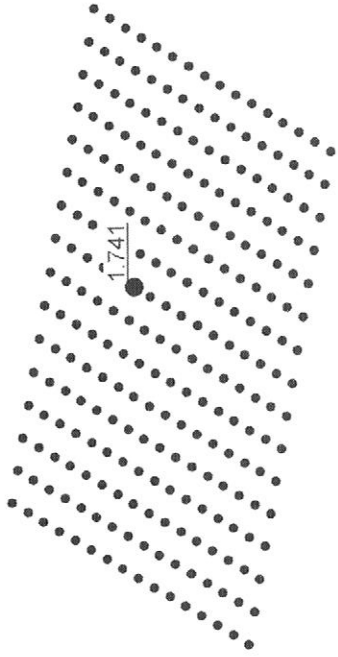
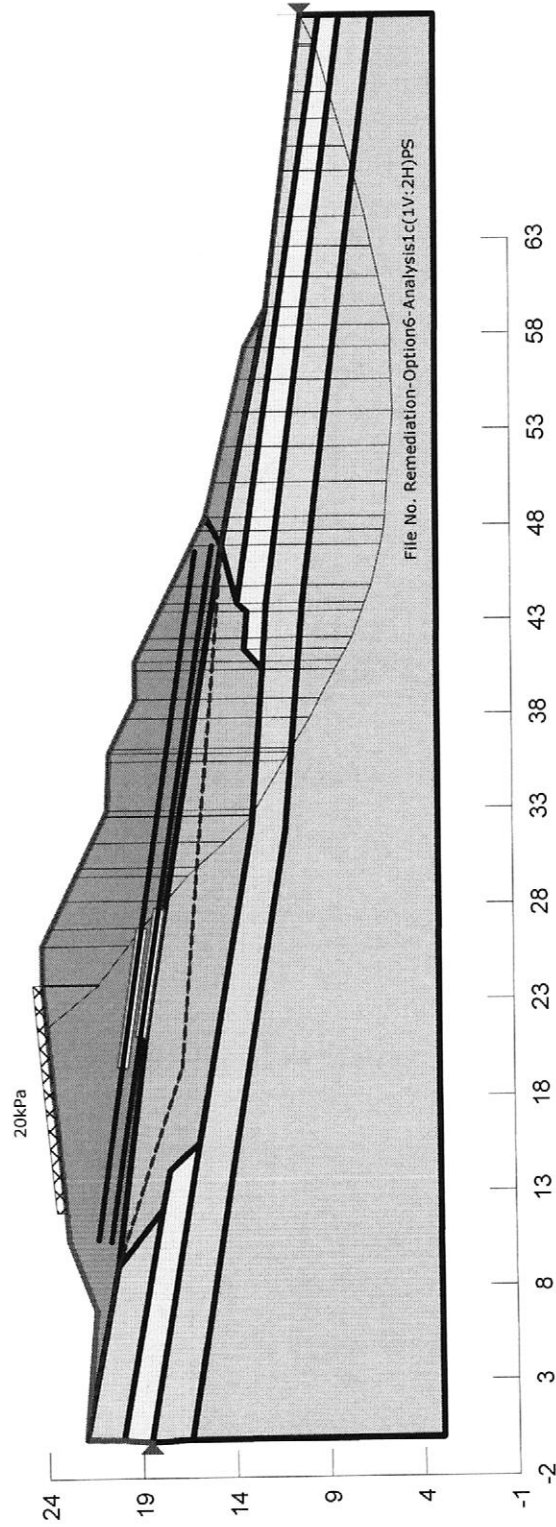
10644/1
 Ballina Shire Council
 Landslip Remediation, Coast Road, Lennox Head
 Section 2, BH1/TP7/TP3 Soil Profile, Post Failure
 Raised Groundwater Level with Toe Drains
 Re-Profiled Batter, Rock Fill Replacement
 2 layers of 200kN Geotextile

- Description: Clay Fill
- Wt: 20
- Cohesion: 5
- Phi: 27
- Description: Silty Clay, F
- Wt: 18
- Cohesion: 3
- Phi: 25
- Description: Silty Clay, St-VSt
- Wt: 18
- Cohesion: 8
- Phi: 27
- Description: Silty Clay, St
- Wt: 18
- Cohesion: 5
- Phi: 25
- Description: Silty Clay, Reduced Strength
- Wt: 18
- Cohesion: 0
- Phi: 11
- Description: Rock Fill
- Wt: 20
- Cohesion: 0
- Phi: 45

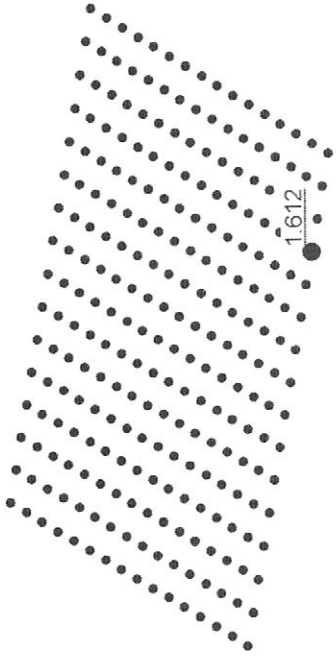
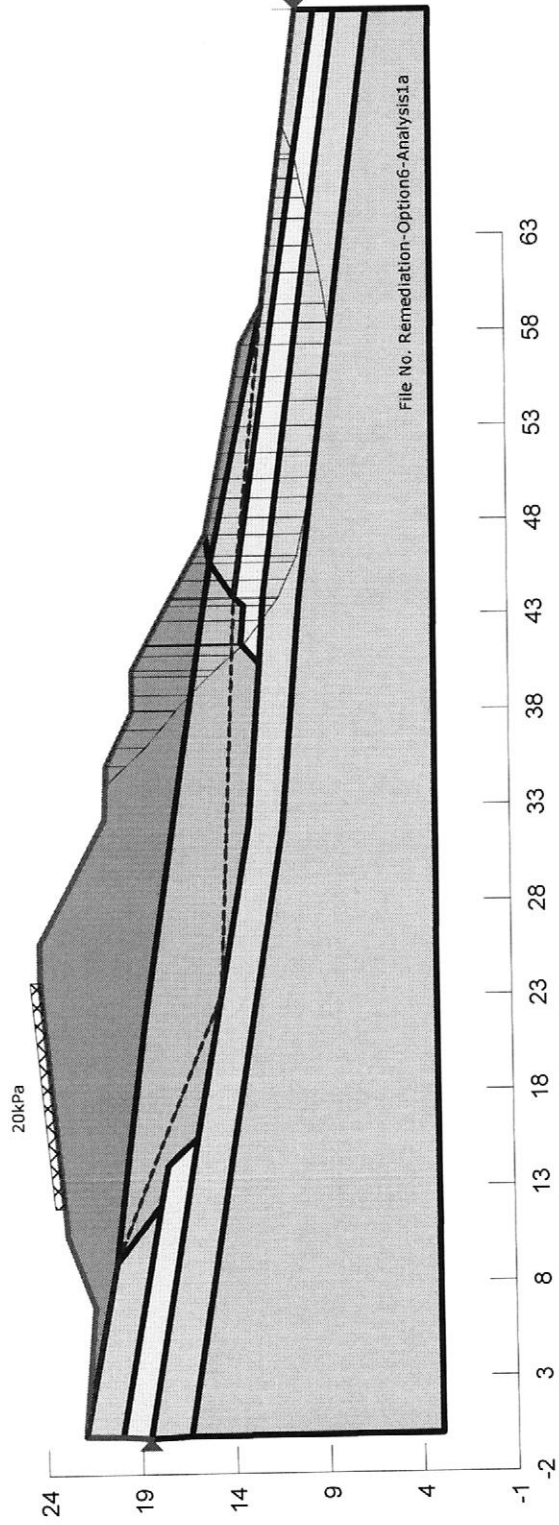
10644/1
 Ballina Shire Council
 Landslip Remediation, Coast Road, Lennox Head
 Section 2, BH1/TP7/TP3 Soil Profile, Post Failure
 Lowered Groundwater Level with Toe Drains
 Re-Profiled Batter, Rock Fill Replacement of Firm Clay

- Description: Clay Fill
 Wt: 20
 Cohesion: 5
 Phi: 27
- Description: Silty Clay, F
 Wt: 18
 Cohesion: 3
 Phi: 25
- Description: Silty Clay, St-VSt
 Wt: 18
 Cohesion: 8
 Phi: 27
- Description: Silty Clay, St
 Wt: 18
 Cohesion: 5
 Phi: 25
- Description: Silty Clay, Reduced Strength
 Wt: 18
 Cohesion: 0
 Phi: 11
- Description: Rock Fill
 Wt: 20
 Cohesion: 0
 Phi: 45

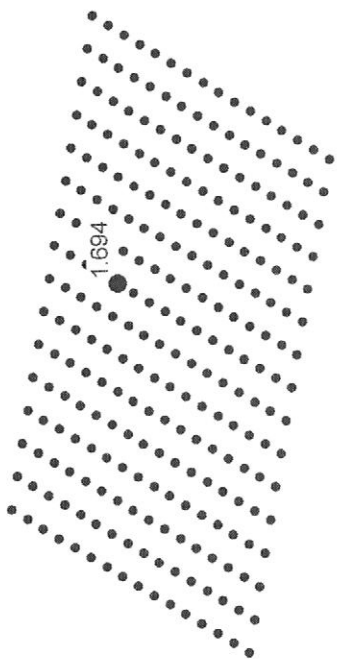
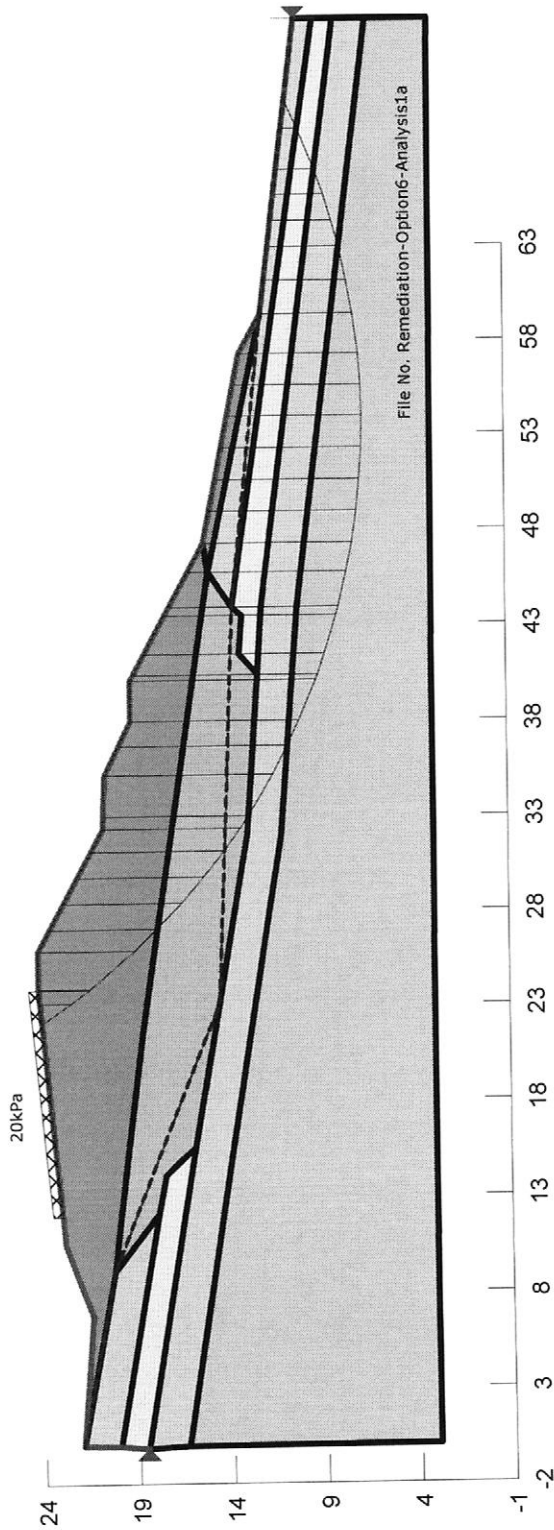
10644/1
 Ballina Shire Council
 Landslip Remediation, Coast Road, Lennox Head
 Section 2, BH1/TP7/TP3 Soil Profile, Post Failure
 Lowered Groundwater Level with Toe Drains
 Re-Profiled Batter, Rock Fill Replacement of Firm Clay

- Description: Clay Fill
- Wt: 20
- Cohesion: 5
- Phi: 27
- Description: Silty Clay, F
- Wt: 18
- Cohesion: 3
- Phi: 25
- Description: Silty Clay, St-VSt
- Wt: 18
- Cohesion: 8
- Phi: 27
- Description: Silty Clay, St
- Wt: 18
- Cohesion: 5
- Phi: 25
- Description: Silty Clay, Reduced Strength
- Wt: 18
- Cohesion: 0
- Phi: 11
- Description: Rock Fill
- Wt: 20
- Cohesion: 0
- Phi: 45

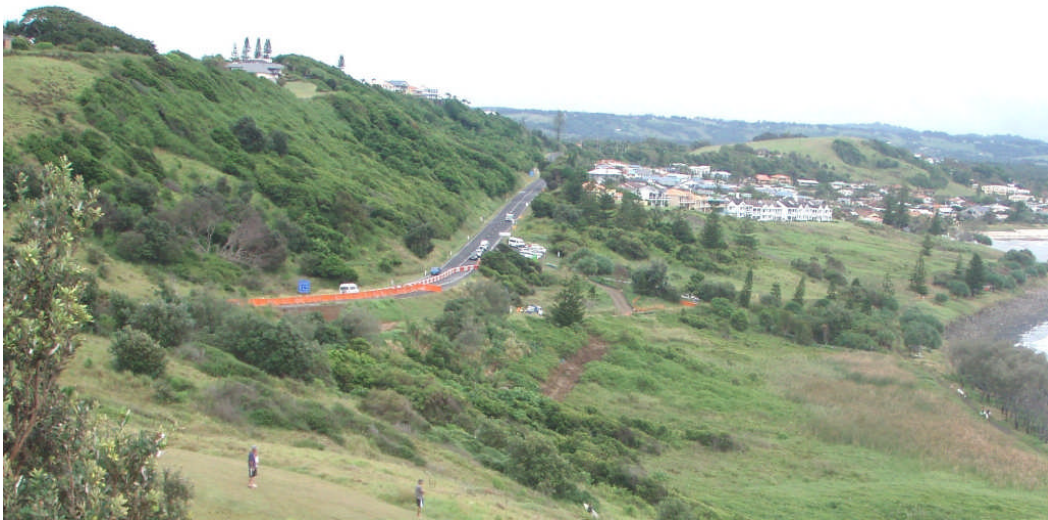
Photo 1: Regional view of Coast Road and the landslide area, looking north west.

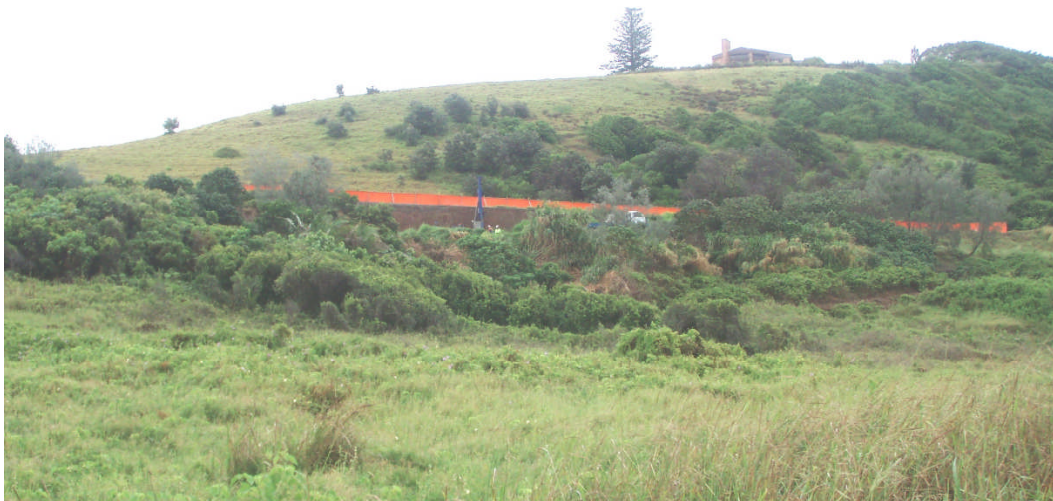
Photo 2: Regional view of Coast Road and the landslide area, looking west.

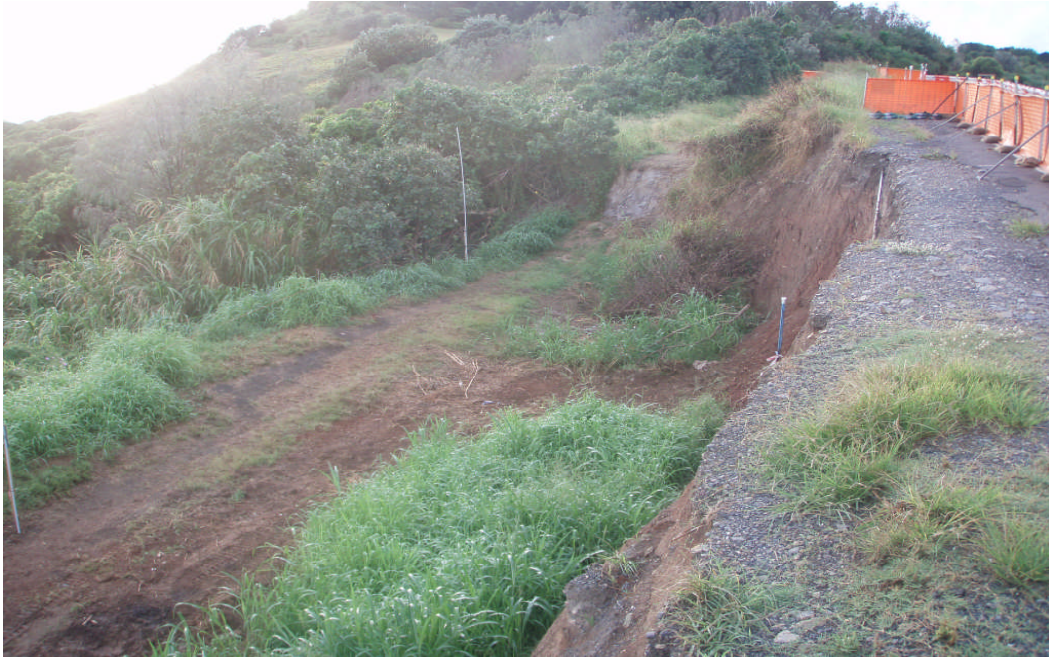
Photo 3: View of landslide head scarp and edge of road pavement, looking south east.
