BALLINA SHIRE COUNCIL

FIG TREE MANAGEMENT

51 Bentinck Street – Ballina  
*Ficus microcarpa var. Hillii*- Root  
Encroachment report

# **Tamar St *Ficus spp.* Root Encroachment Report**

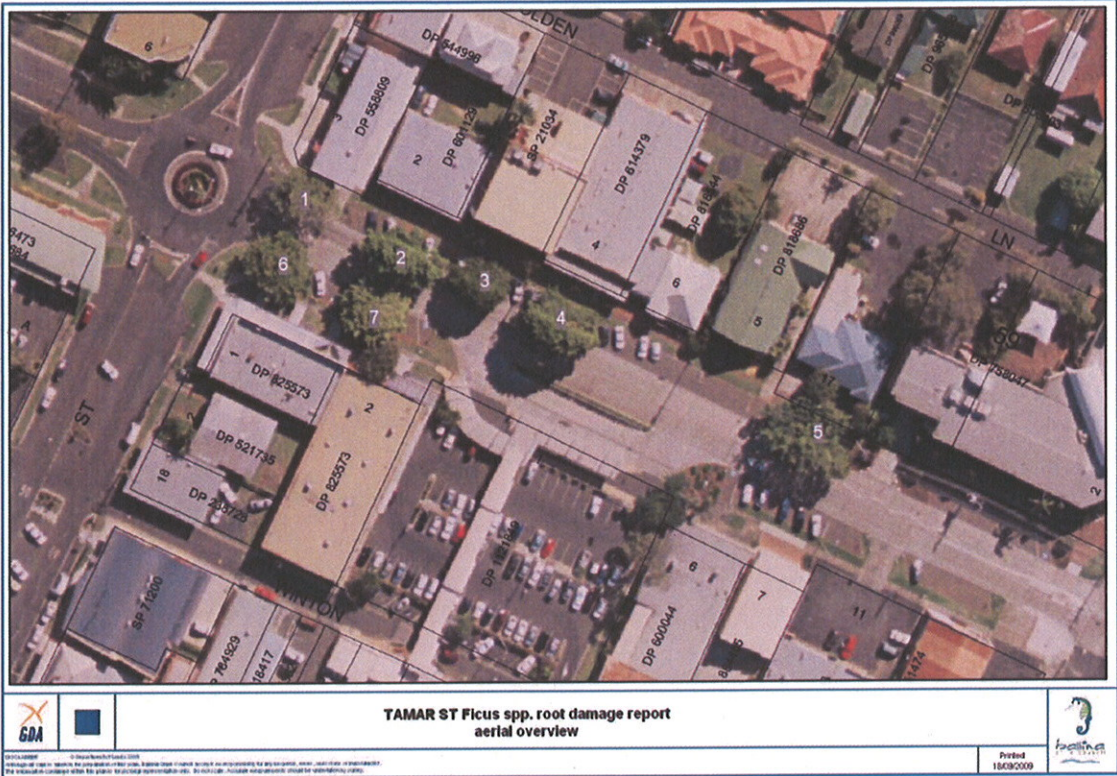
Photo 1 Aerial Image of nominated trees

The trees are located in the road reserve in Tamar Street between the intersections of Tamar / Moon Streets and Tamar and Cherry Streets. The trees of most concern are located on the northern side of Tamar Street at the western end in front of 83 - 77 Tamar Street.
