BALLINA SHIRE COUNCIL

**ATTACHMENTS TO
LOCAL TRAFFIC COMMITTEE
MEETING BUSINESS PAPER**

Wednesday 10 June 2020

Traffic Signal Warrants Study

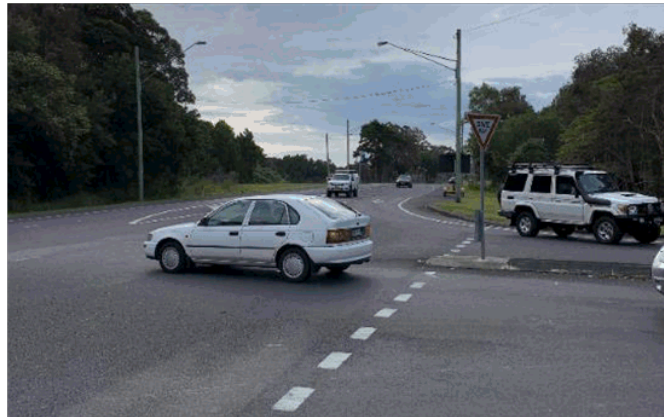
Photo No. 5: Location of hold line, set well back from through lane

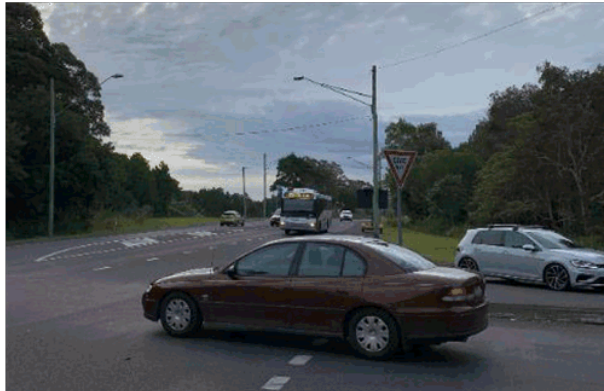
Photo No. 1: Sight distance to the north with turning vehicle (note through vehicle beside rear of bus, still obstructed with stopped vehicle in front of hold line)

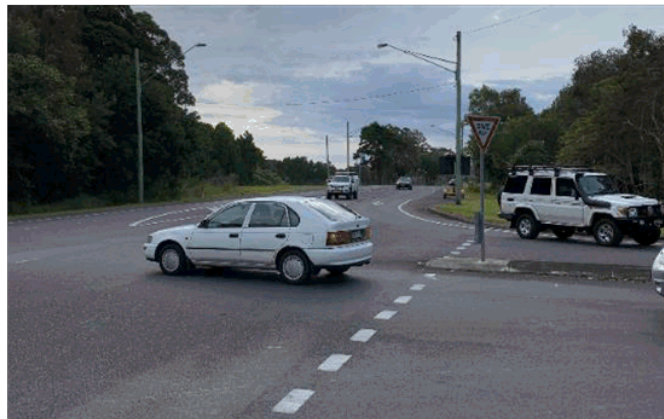
Photo No. 2: Location of existing hold line, set well back from through lane

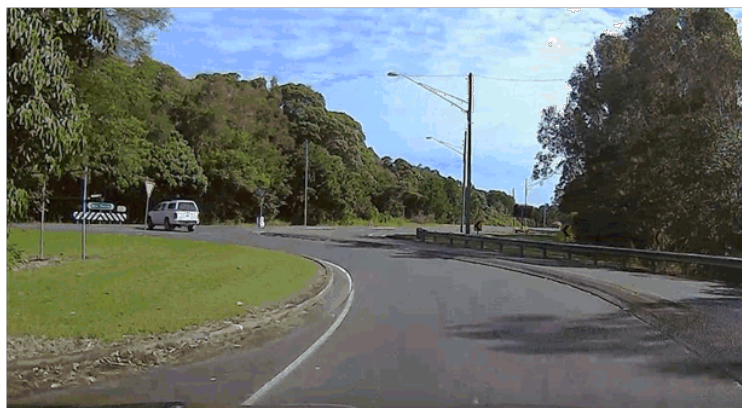
Photo No. 3: Existing westbound approach to intersection – single lane. Note narrow lane eastbound side

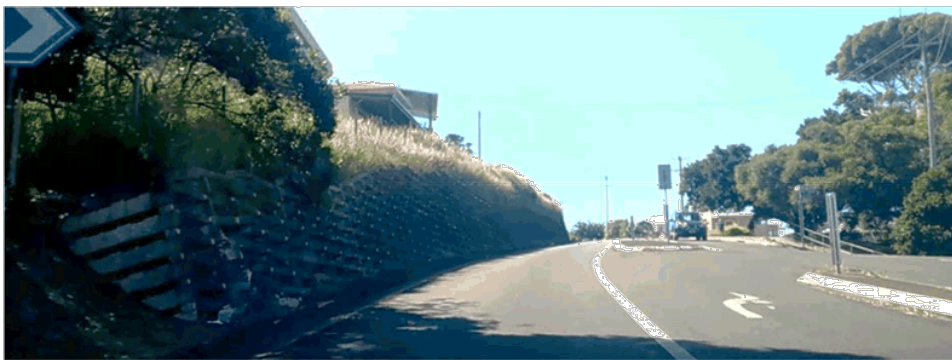
Photo 6 – CH 350 – View to the EAST – Intersection with Compton Drive

<p>4.5 Guard rail protection There is a timber board affixed to the rear of the existing guard rail on the south west corner of the Hill Street / Compton Drive intersection, adjacent to the shared path. This is presumably to prevent cyclists from incurring an injury if they were to collide with the unprotected rear of the guardrail. However, the board appears to be insufficient to achieve this goal and is presumed to be non-compliant with current Australian Standards for shared paths and cycleways.</p> <p>It is recommended that the intention of this fixture be considered to ensure it does not pose an additional safety risk, specifically for cyclists.</p>	<p>Comment only</p>	<p>Yes</p>	<p>Will be investigated.</p>
<p>5.0 OTHER</p>			
<p>5.1 Vegetation reducing intersection sight distance Vegetation on north west side of Hill Street / Coogee Street intersection partly obscures view of eastbound traffic from motorists waiting to turn out of Coogee Street.</p> <p>There is a risk that a vehicle leaving Coogee Street will be struck by eastbound through traffic.</p> <p>It is recommended that all roadside vegetation be monitored and maintained to ensure signage is visible and intersection sight distance is maximised.</p>	<p><i>Improbable Minor</i></p> <p>Low</p>	<p>Yes</p>	<p>-</p>

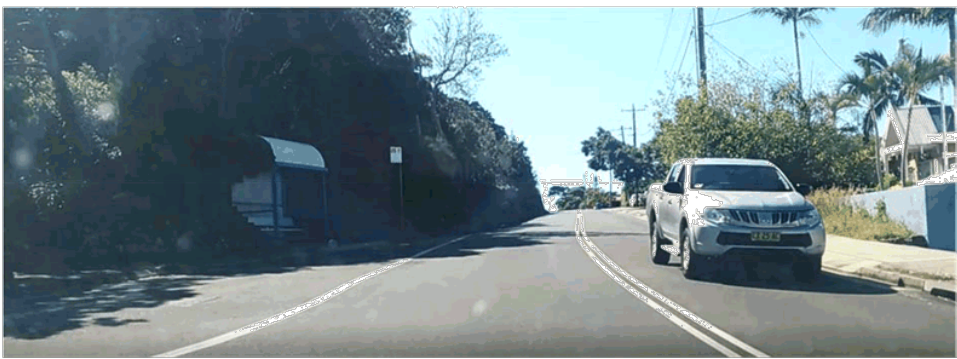
Photo 9 – CH 650 – View to the EAST – Bus Stop

Audit findings	Risk Ranking	Client	
		Accept Yes/No	Comments
<p>1.6 Bus obscuring view for motorists existing Coogee Street A bus stopped in the bus zone on Pine Avenue immediately east of Coogee Street would obscure the view of westbound traffic from motorists wishing to turn right out of Coogee Street. This may result in a broadside crash between the right-turning vehicle and westbound through traffic.</p> <p>It is recommended that investigations be made into the possibility of relocating this bus stop.</p>	<p><i>Occasional Limited</i></p> <p>Low</p>	No	This would be cost prohibitive at this location given the physical constraints.
<p>1.7 Narrow carriageway on Hill Street The carriageway and verges on Hill Street between Compton Drive and Manly Street feel narrow from the perspective of a motorist. The presence of a 1.5-2.0 m high retaining wall less than a metre from the edge of the travel lane (kerb lip) of the eastbound lane and a footpath immediately behind the kerb of the westbound lane does not provide much (if any) room for error along this stretch of road.</p> <p>There is a risk that any errant vehicle will collide with oncoming vehicles/pedestrians/cyclists, given the lack of available space to avoid a collision.</p> <p><i>Refer to 5.2 for recommendations that will mitigate this risk.</i></p>	<p><i>Occasional Serious</i></p> <p>High</p>	Yes	To the extent that it could be addressed by adoption of 5.2 (reduction in speed zone).

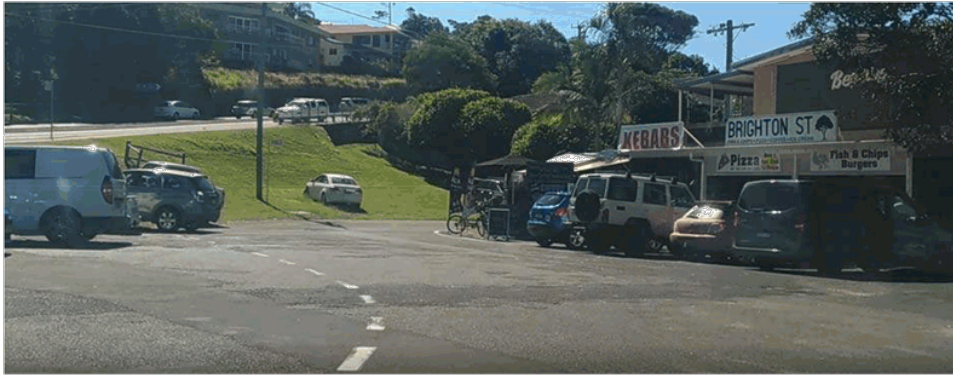
<p>2.2 Informal / formal parking areas north of the Brighton Street intersection The formal and informal parking area north of the Brighton Street intersection adjacent to the takeaway shops and Range Street includes areas of unusual angles and dimensions, allowing for the use of some areas (e.g. parking, access or manoeuvring) to be unclear.</p> <p>During peak periods when parking is in high demand, there is a risk that motorists will park in such a way to cause collisions with other motorists attempting to park/unpark or circulate within the area.</p> <p>It is recommended that the parking areas be formalised with the aim to maximise parking and safety for motorists and pedestrians (<i>refer audit finding 1.1</i>).</p>	Occasional Minor Medium	Yes	As above.
<p>2.3 Parking in Range Street It is noted that residents have complained about service vehicles related to the takeaway food shops park at the end of Range Street while loading/unloading, temporarily blocking passage for other vehicles. This could be a hazard if emergency services were unable to enter/exit Range Street as needed.</p> <p>Reconfiguration of the area is recommended to alleviate this issue.</p>	Comment only	Yes	As above.

Photo 6 – Brighton Street, parking and take-away food shops

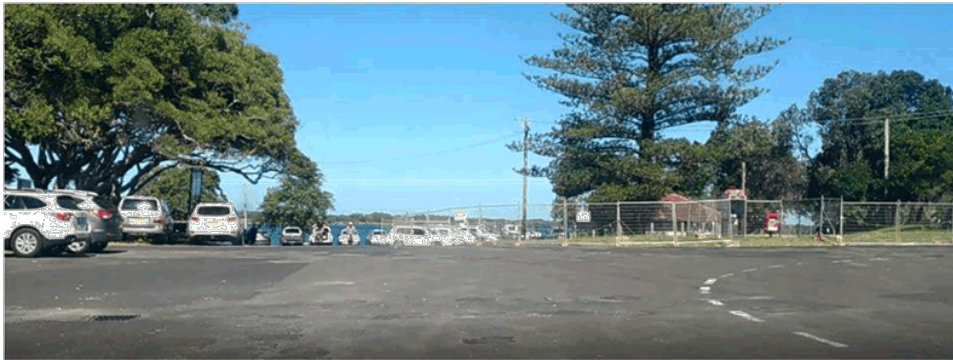
<p>1.5 Intersection of Brighton Street (east-west) and Brighton Street (north-south) In plan view, the geometry of this 'intersection' suggests that the two sections of Brighton Street join with a tee-intersection. However, the linemarking, lack of give-way (or similar) signage and ill-defined edges create a space of confusion, with motorists clearly unsure which movements have right-of-way. This area was observed to operate on an ad-hoc basic, with motorists using eye-contact and hand signals to determine who would proceed with competing movements. During peak times, this area is well known to be chaotic and disorganised.</p> <p>Confusion within a roadway, even at low speeds creates a risk of collisions between motorists who perceive the environment in different ways.</p> <p>It is recommended that this intersection be formalised, including appropriate signage, linemarking and edge restraints (<i>refer audit finding 1.1</i>).</p>	<p>Probable Minor</p> <p>High</p>	Yes	As above.

Photo 12 – 'Intersection' of Brighton Street (east-west) and Brighton Street (north-south)

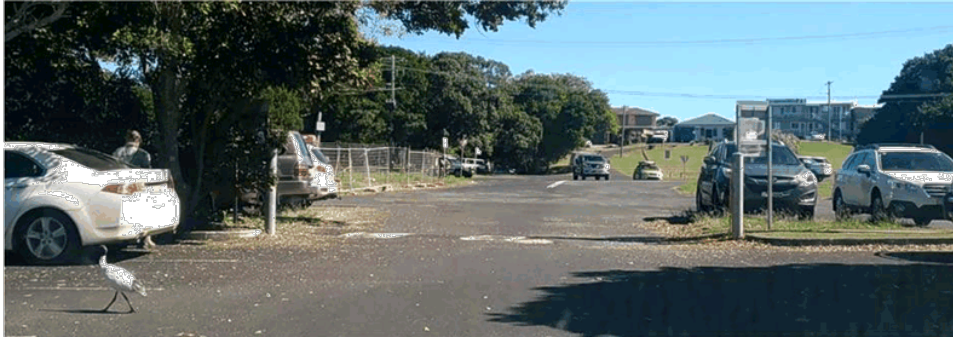
Photo 14 – Shaws Bay Hotel car park, view of Brighton Street intersection

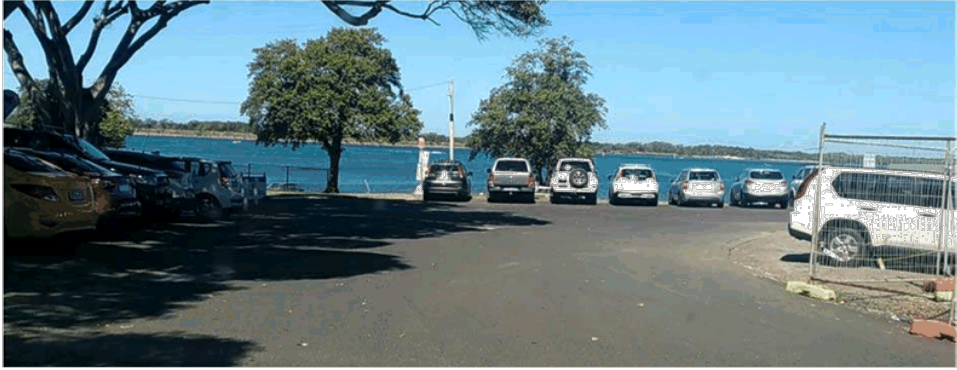
Photo 17 – Brighton Street, view of parking area

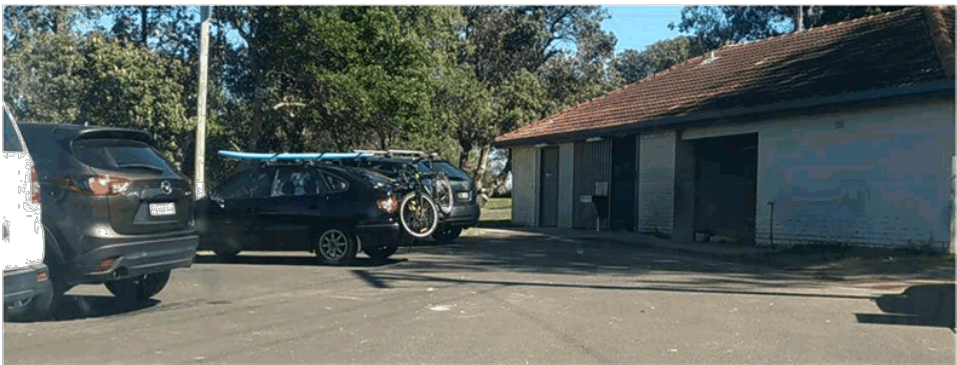
Photo 19 – Parking and amenities building

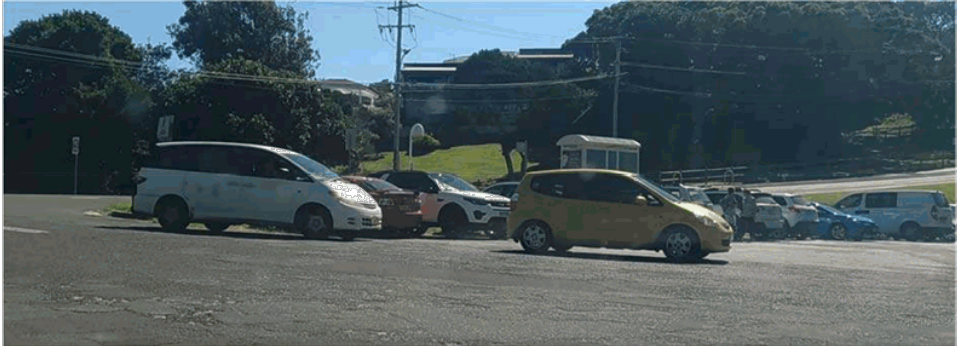
Photo 23 – Intersection of Brighton Street (east-west) and Brighton Street (north-south)

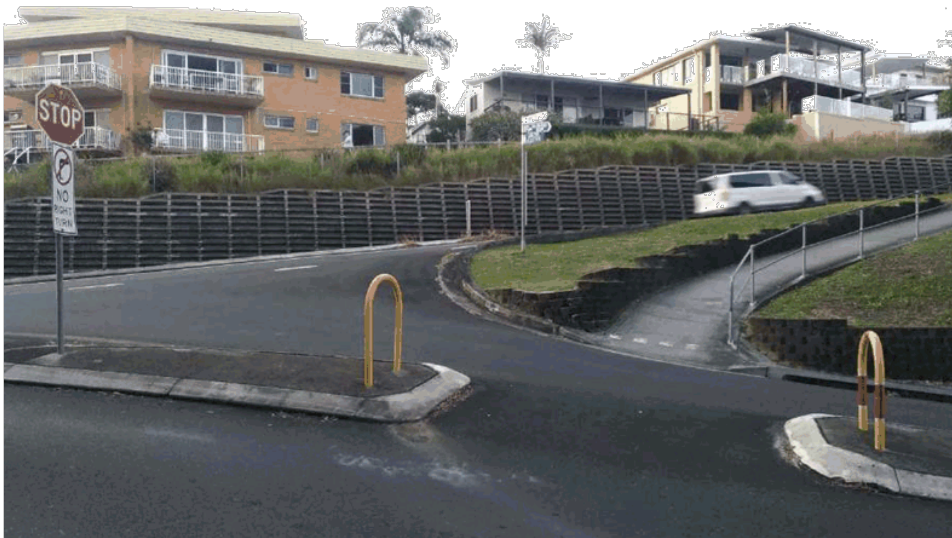
Photo 27(a) – Compton Drive at Hill Street intersection, refuge island

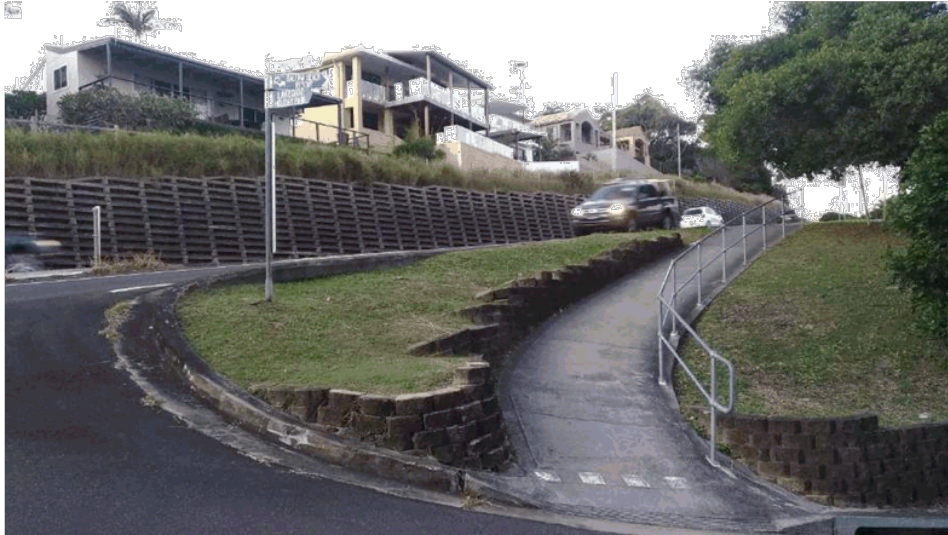
Photo 27(b) – Compton Drive at Hill Street intersection, footpath

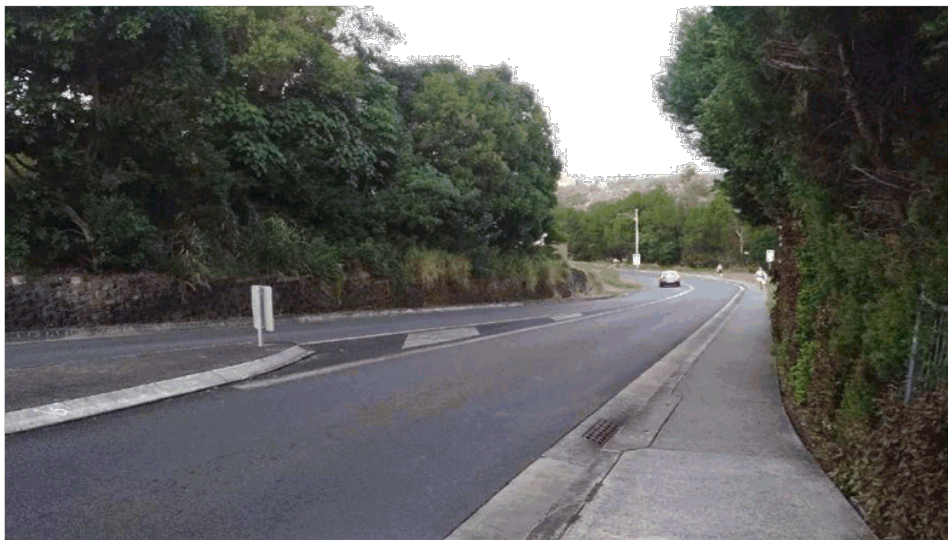
Photo 27(c) – Compton Drive, footpath

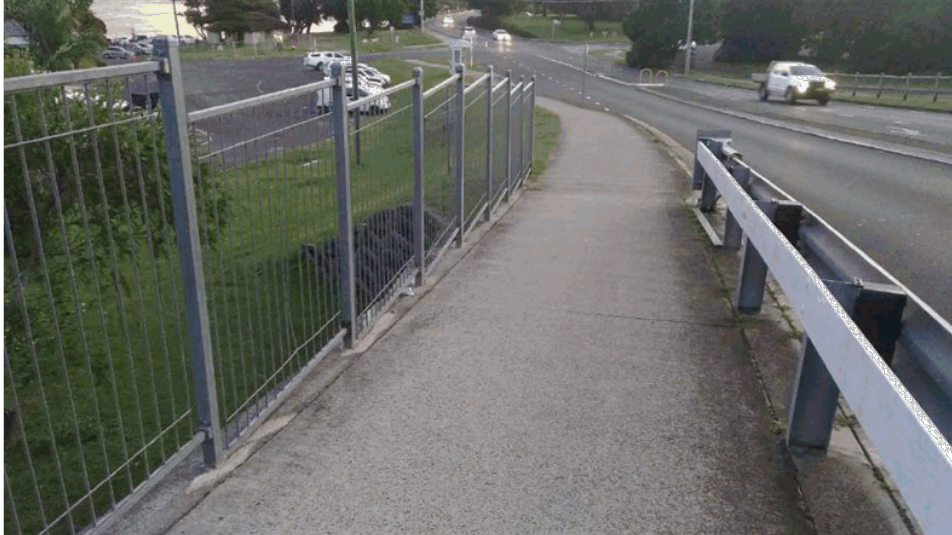
Photo 28 – Hill Street, shared path, barrier fencing, guard rail with timber board

3.2	Repair 'Shared Path' sign on the south eastern corner of the Hill / Brighton Street intersection.
4.5	The intention and appropriateness of the timber board fixed to the rear of the guard rail on the south west corner of the Hill Street / Compton Drive intersection will be investigated and compliance checked against current relevant standards.
Other (from Section A RSA)	Apply to TfNSW for a speed zone review with the intention to gain approval to reduce the speed zone from 60 km/h to 50 km/h for the full length of the Section A area, thus improving the safety of the road environment by reducing the likelihood and/or severity of potential crashes.
