# ADDENDUM to the Richmond River Estuary Processes Study

For Richmond River County Council

PROJECT NUMBER: BB074

11/05/2009

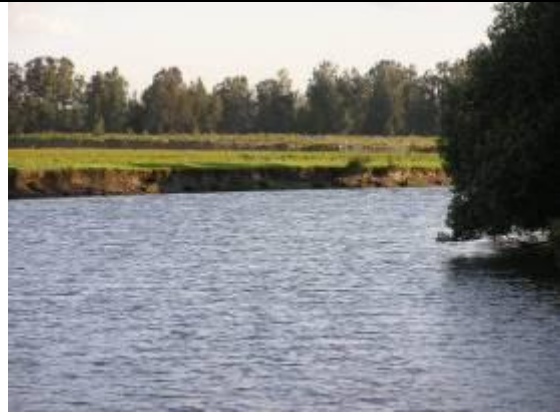
Floodplain area and T-tree plantation in the background of picture adjacent to eroding shoreline in North Creek

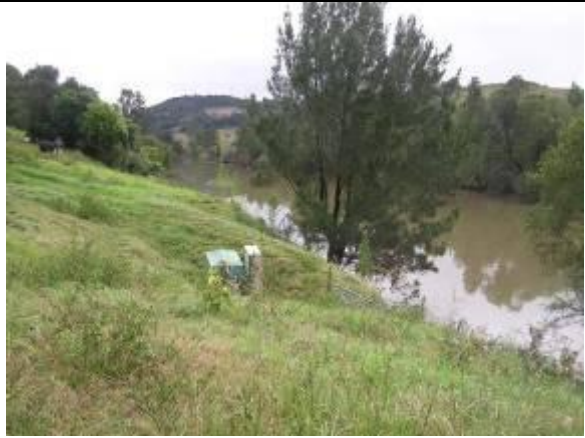
Dairy cattle access to the river has been controlled at this site.
