Arboricultural Impact Assessment Report

Cherry St. Fox St. Roundabout BALLINA NSW 2478

Prepared for: Ballina Shire Council

Prepared on: 08 July 2020

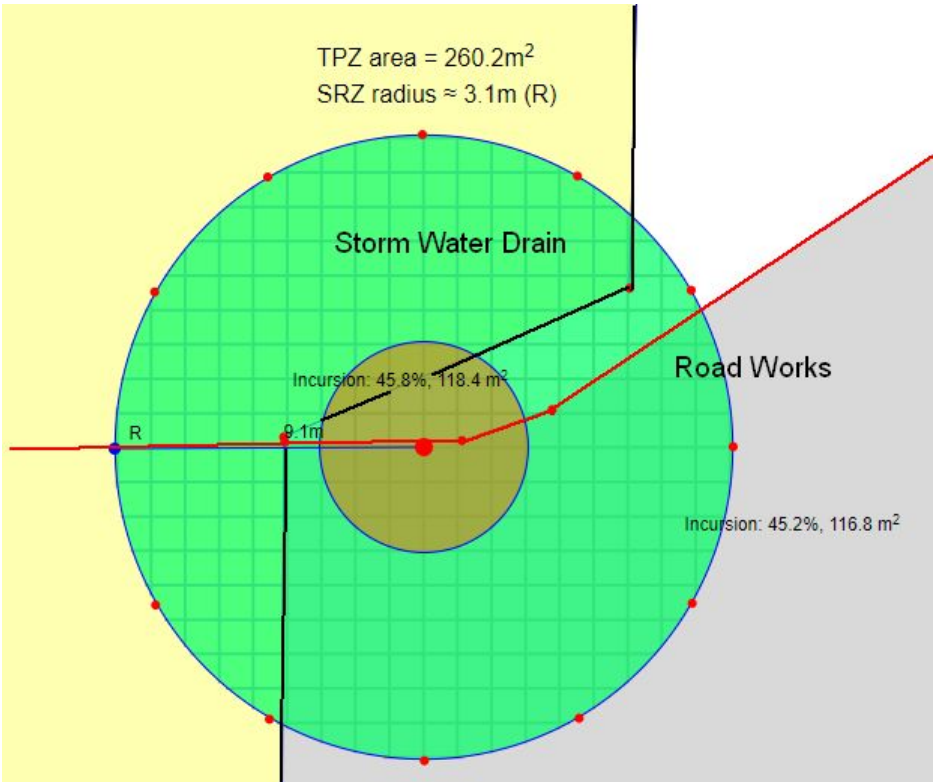
Appendix 2: TPZ incursion calculator showing development (road & drainage)

TPZ incursion calculator showing development Tree 2. Road works
