11.2 Administration Centre - Air-Conditioning Status

11.2 Administration Centre - Air-Conditioning StatusTiming of programed replacements

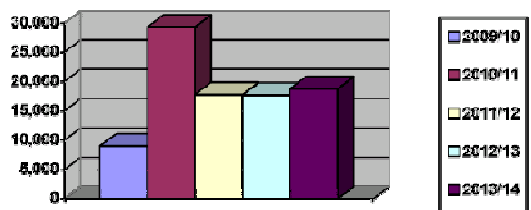
The reactive maintenance can be quite variable and often relates to weather conditions received during the summer period. Over recent years there has been replacement of major parts on the roof top AC units which was primarily related to corrosion. The large variation in the per annum maintenance costs for the AC units at the CSC can be seen in the graph below.

In the details above it can be seen that the AC units that are exposed to the weather on the roof top of the CSC, will, and do, incur the majority of the ongoing reactive maintenance costs and they also require standard periodic preventative maintenance, as required by all the AC units at the building.
