Notice of Local Traffic Committee Meeting

A Local Traffic Committee Meeting will be held in the Ballina Shire Committee Room, 40 Cherry Street, Ballina on **Wednesday 10 June 2020 commencing at 10.00 am.**

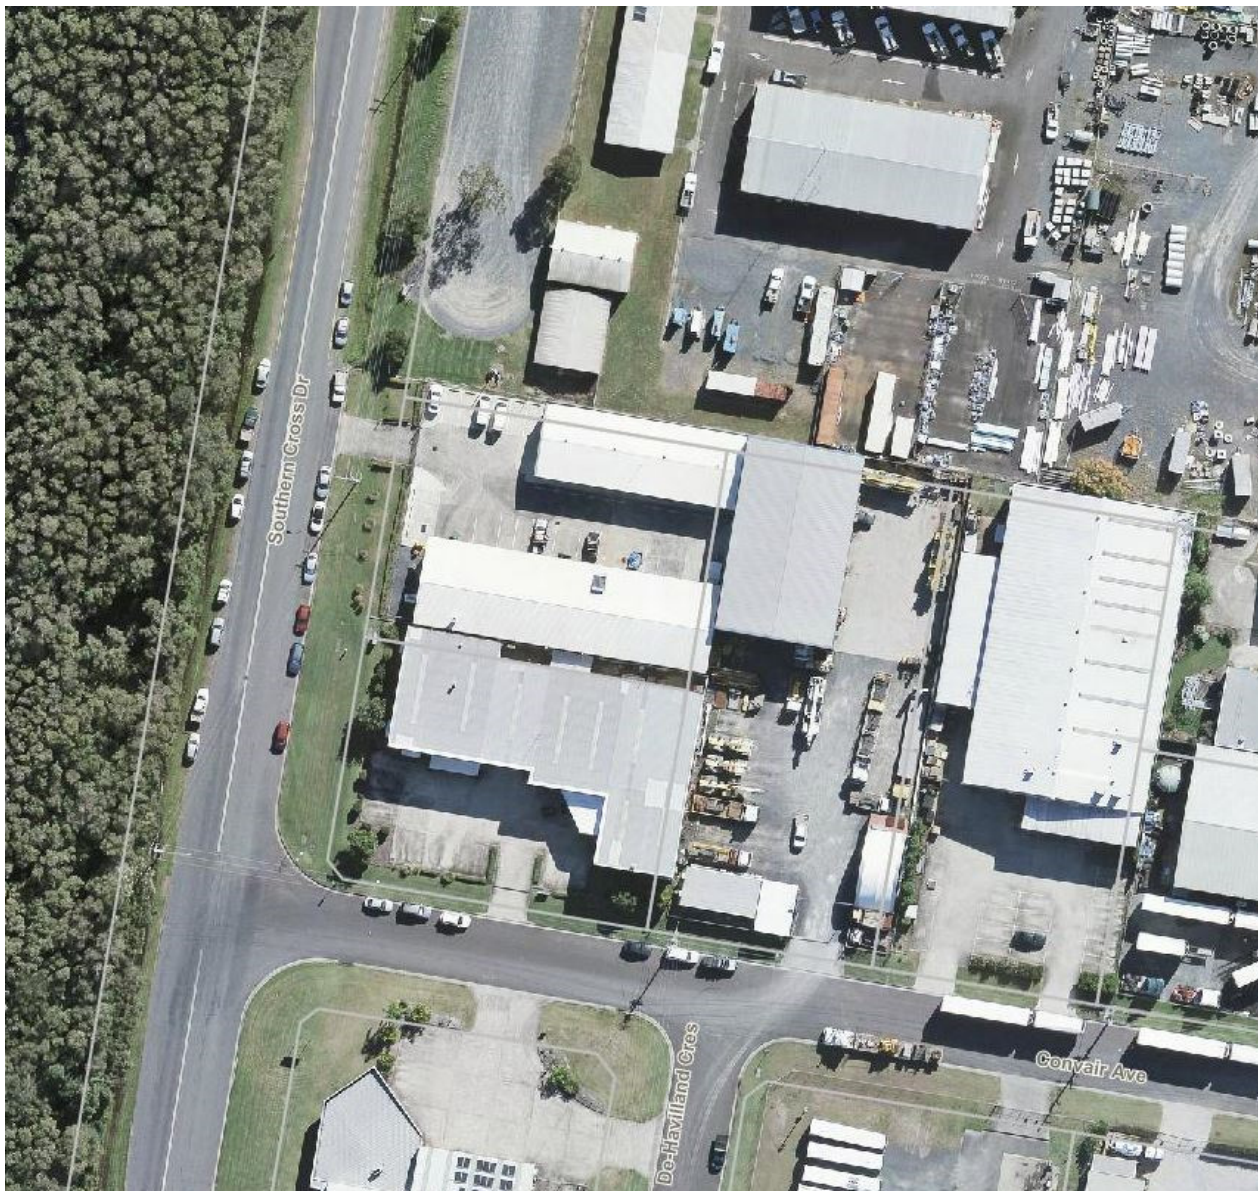
1. Aerial View - Southern Cross Drive and Convair Avenue - Note NO STOPPING on west side Southern Cross Dr has been extended since this photo was taken
2. Long Term Vehicle Parking - Southern Cross Drive, Ballina

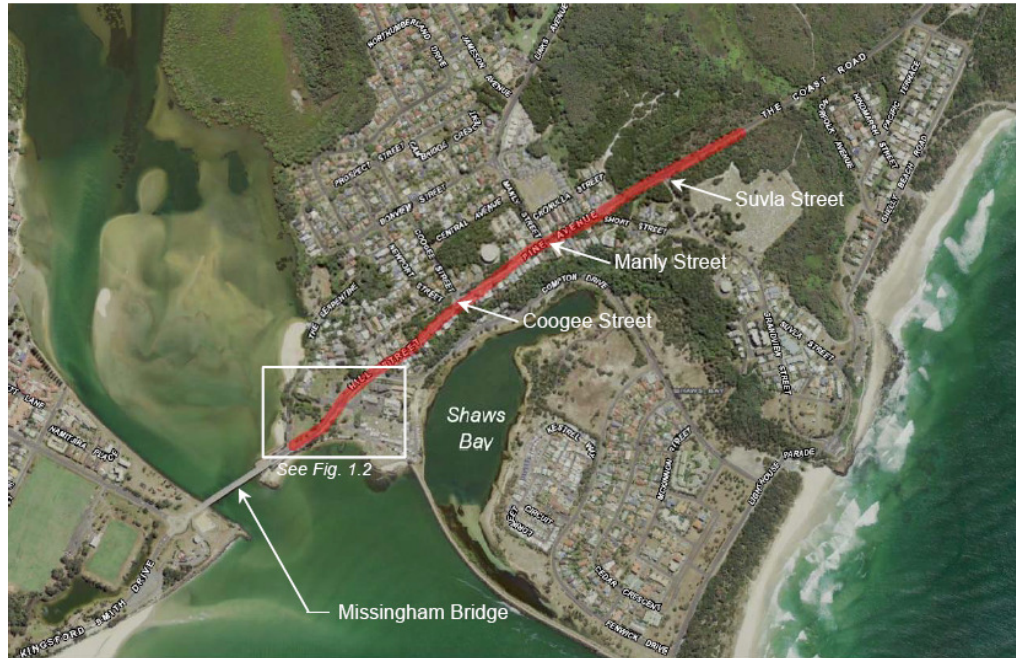
SECTION A - The Coast Road/Pine Avenue/Hill Street Between Missingham Bridge and 80kph Zone North of Suvla Street

Audit findings	Risk Ranking
1.0 GEOMETRY	
<p>1.1 Vehicles queuing to turn right into Brighton Street Several eastbound vehicles were observed queuing to turn right into Brighton Street from Hill Street. Eastbound through traffic was required to use the auxiliary lane to pass these vehicles. The auxiliary lane appeared somewhat short given the number of vehicles observed in the through lane waiting for a gap in the oncoming traffic to allow a right turn, and it is expected the volumes of traffic for all manoeuvres in the area would be greater during peak summer periods.</p> <p>Vehicles travelling eastbound at 60 km/h off Missingham Bridge, rounding the left-hand bend may not perceive the stopped vehicles ahead in the through lane and may rear-end vehicles queued to turn right.</p> <p>It is recommended that consideration be given to reconfiguration of this intersection in conjunction with the area to the east of Brighton Street.</p>	<p><i>Occasional Limited</i></p> <p>Low</p>

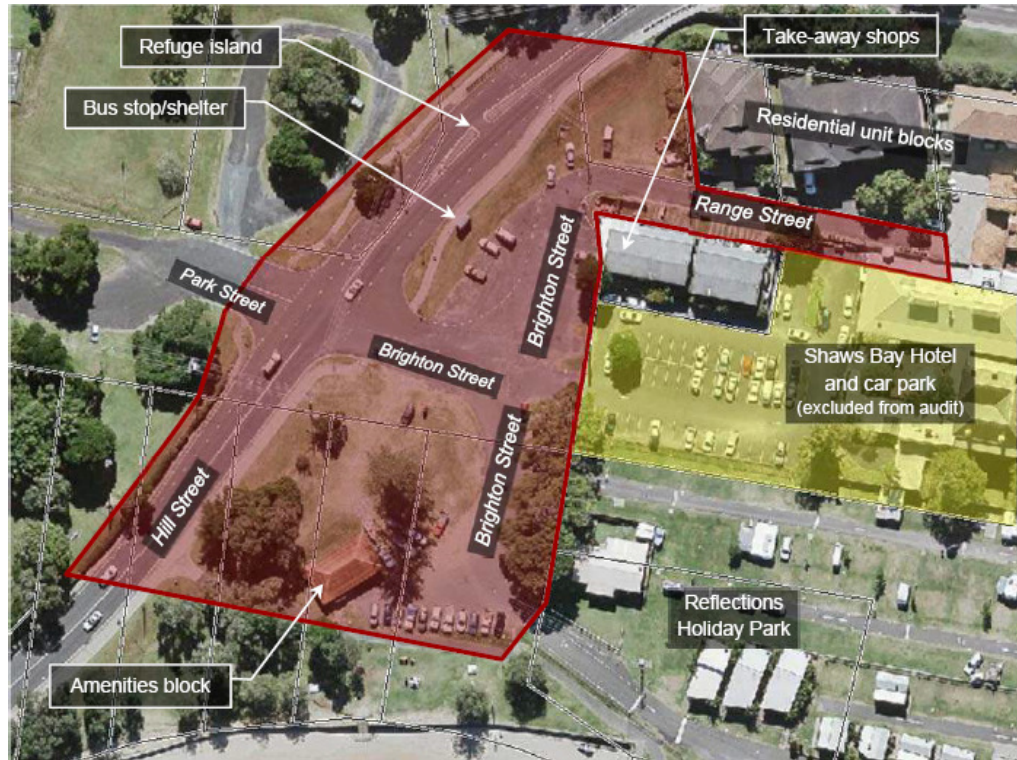
SECTION B - The Hill Street/Park Street/Brighton Street intersection and the area to the east including Range Street, entrances to Shaws Bay Hotel and Caravan Park and associated formal and informal parking areas on sealed and vegetated adjacent areas

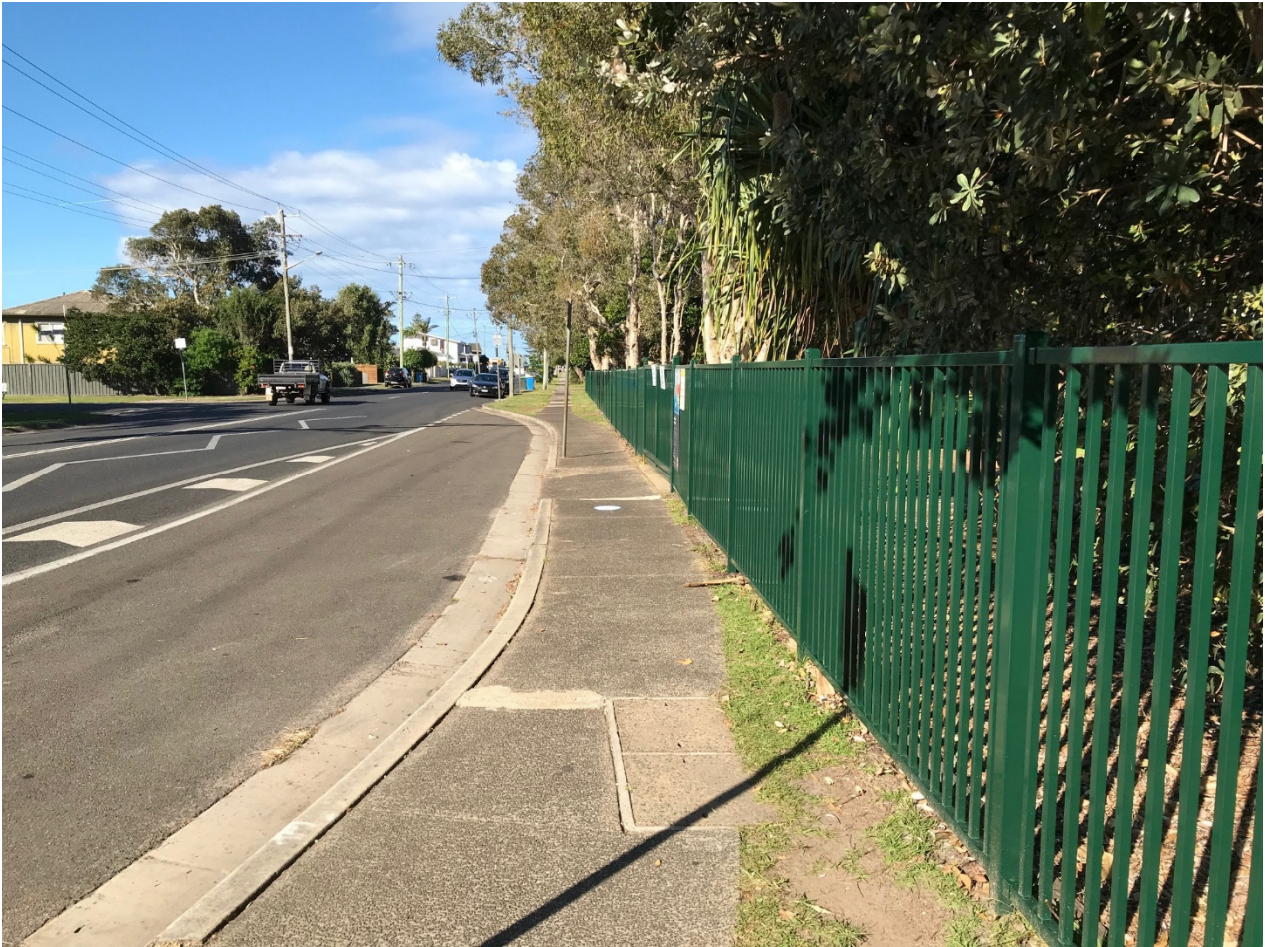
1. Lennox Head School Bus Zone - New Fence
2. Lennox Head School Bus Zone - Old Fence
3. Lennox Head School Bus Zone - Aerial Photo
