# Tuckombil and Stokers Quarry Evaluation and Strategic Options Report

Ref no.:	1467_221_001
Document Title:	Tuckombil and Stokers Quarry Evaluation and Strategic Options Report
Principal Author:	Rod Huntley
Client:	Ballina Shire Council

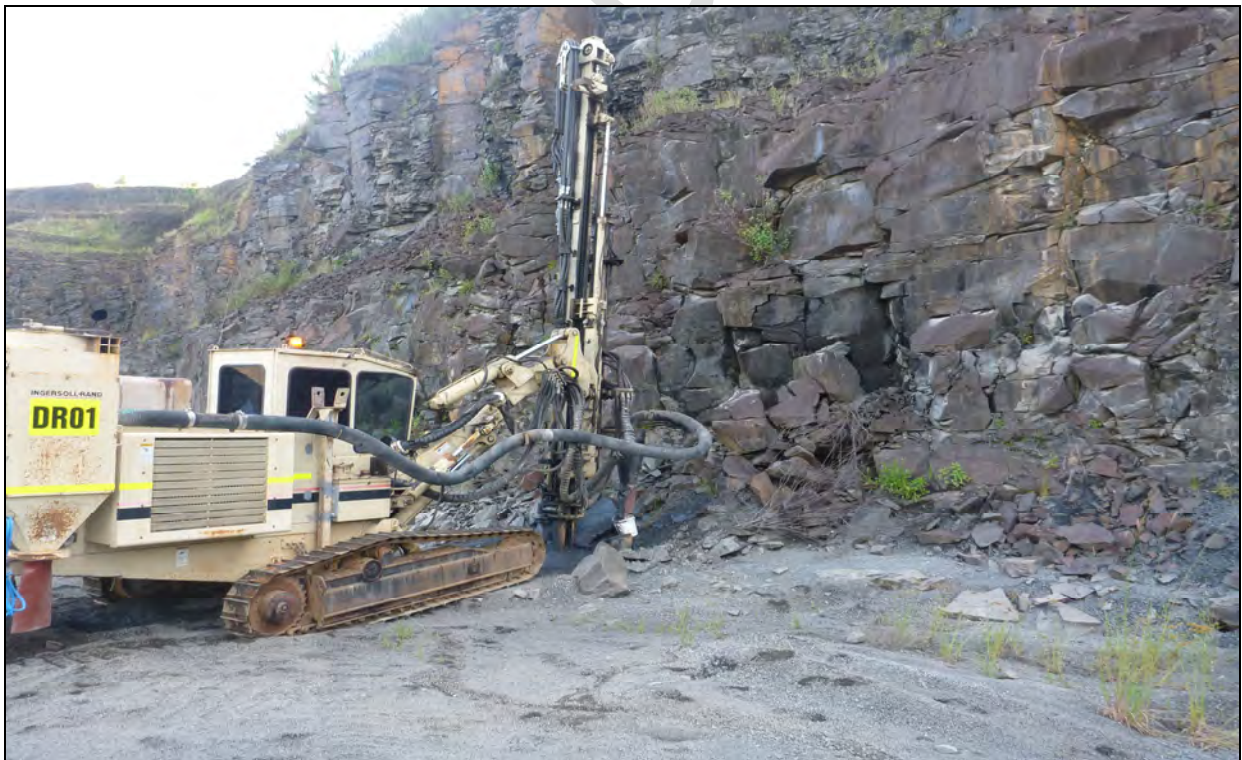
Plate 1 Drilling during the Tuckombil Quarry Resource Investigation

*Note:* a full risk assessment was completed for drilling each hole and in this instance the high wall was assessed for stability, loose rocks and the potential for slope failure.

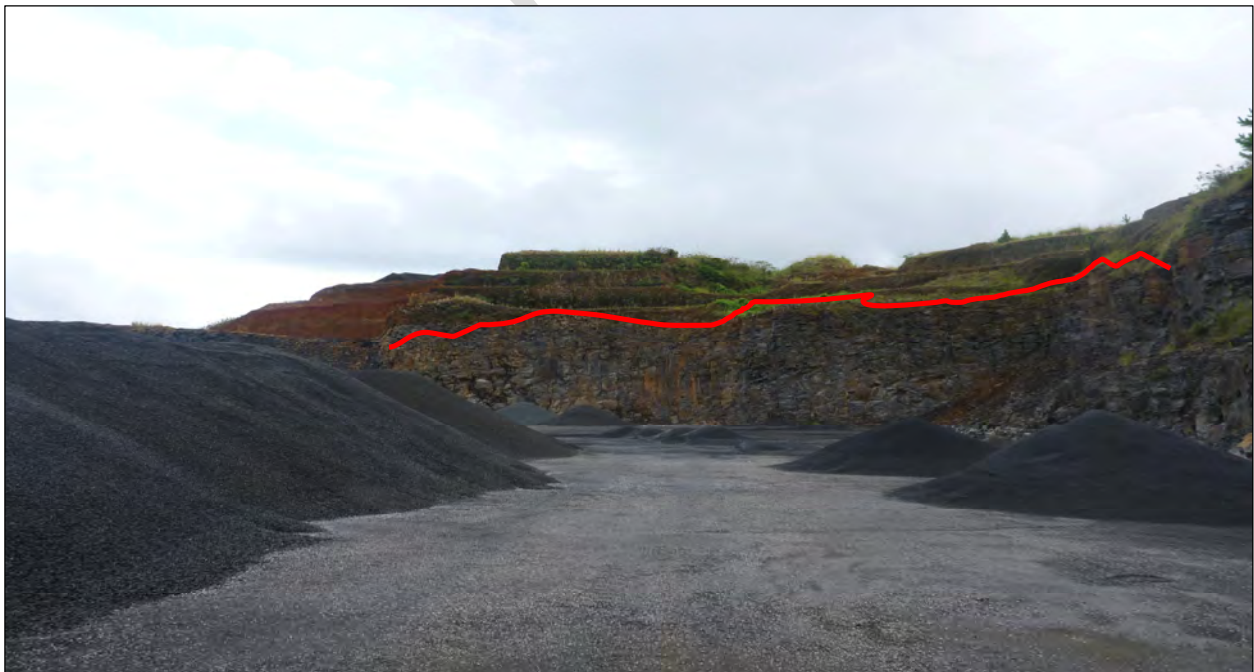
Plate 8 North Wall Weathering Profile at Tuckombil Quarry  
Red line denoting the transition from distinctly weathered material to unweathered basalt. This photograph also shows the rapidly thickening overburden sequence which develops to the north of site.

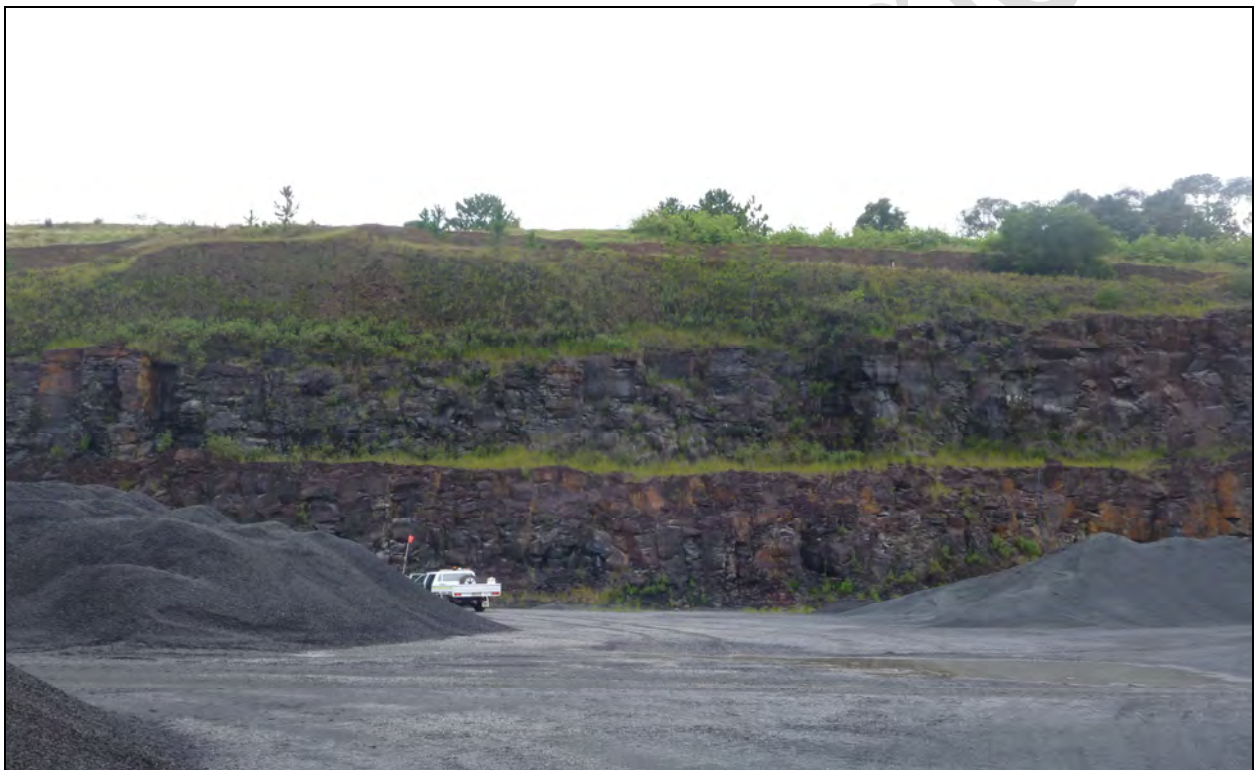
Plate 9 East Wall Weathering Profile at Tuckombil Quarry  
The thickness of overburden being the chief issue for further development in this orientation.

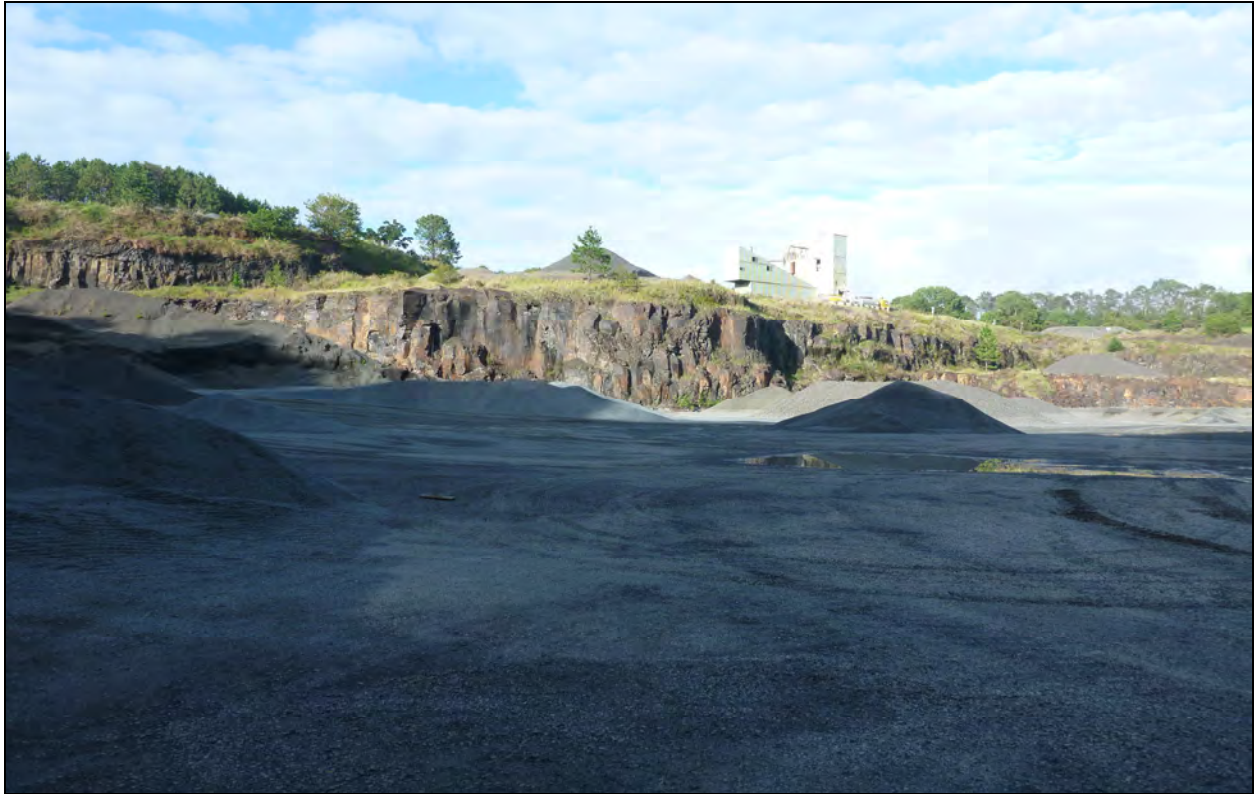
Plate 10 South Wall Resources at Tuckombil Quarry

*Note:* high quality columnar basalt resources remain to be extracted under the asphalt plant. A total of 56,500m<sup>3</sup> of material could be extracted from under the asphalt plant once it is removed.

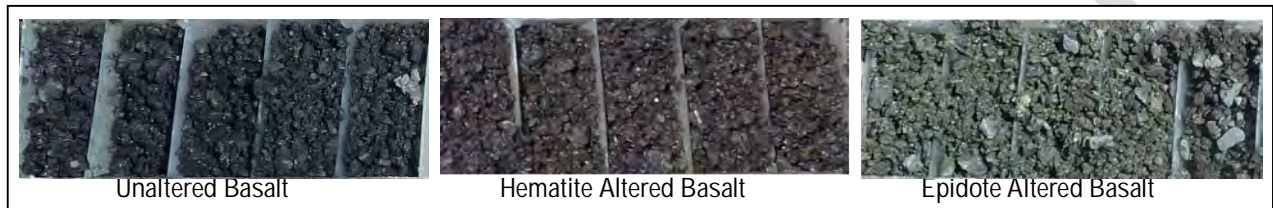
Plate 11 Alteration of Basalt at Tuckombil Quarry

The basalt is grey black in colour, when unaffected by weathering, a red colour when altered by hematite and a green colour when altered by chlorite, illustrated in PLATE 11 – ALTERATION OF BASALT AT TUCKOMBIL QUARRY. Textures recognised were generally consistent with the basalts of the area, being flow banded in part but with generally a massive homogenous to columnar appearance. Dominant minerals in the basalt are olivine, sanidine feldspar and pyroxene, whilst secondary minerals include calcite, ilmenite, chlorite, goethite and sphene. Smectite and goethite are also likely to be present in the more weathered material recognised on site.

The distinctly weathered basalt material generally appears of low to medium strength, and should provide source material for production of low range specification products. The slightly weathered to unweathered material appears hard, strong and durable and will continue to provide an excellent source of quarry material. The rock has limited free silica content and is predicted to be relatively innocuous in terms of alkali silica reactivity.
