BALLINA SHIRE COUNCIL

**ATTACHMENTS TO
LOCAL TRAFFIC COMMITTEE
MEETING BUSINESS PAPER**

Wednesday 10 June 2020

Traffic Signal Warrants Study

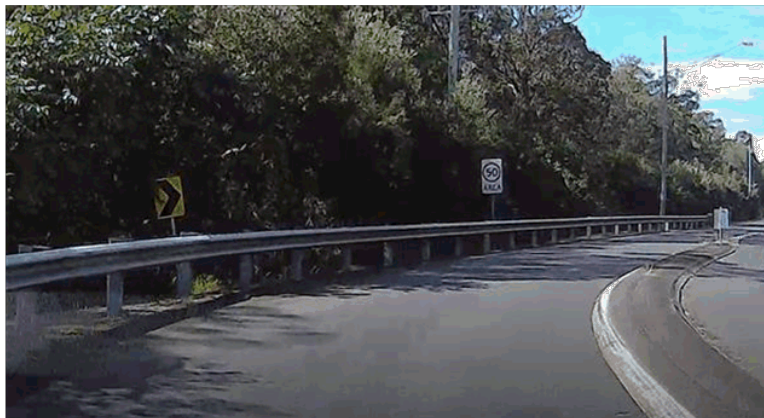
Photo No. 6: Narrow eastbound lane – Byron Street

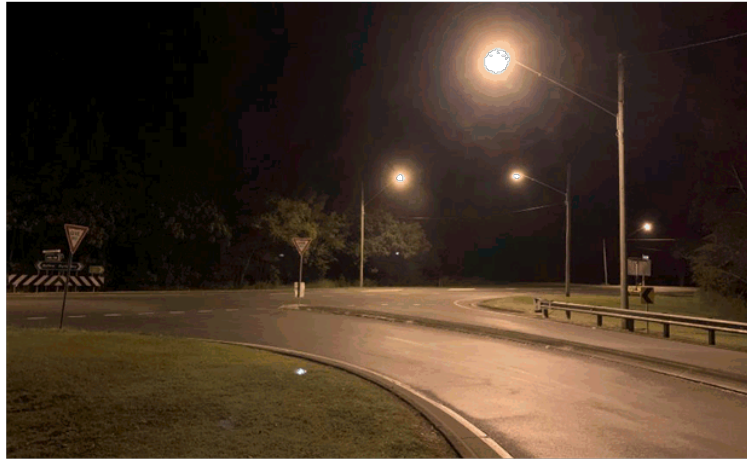
Photo 7: Intersection is well lit

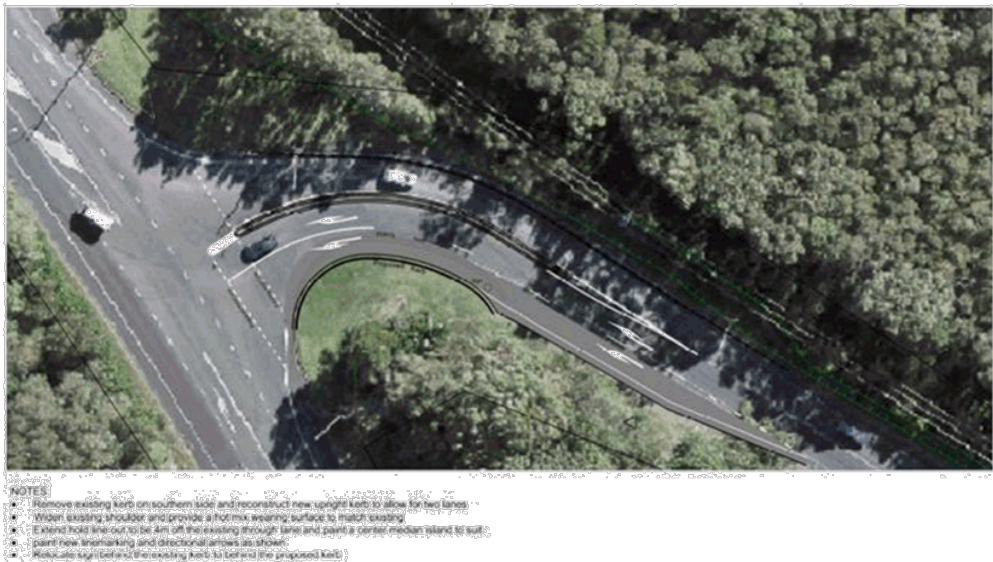
Figure 5: Concept Design

To assist in alleviating this situation, it is proposed to construct the low cost modification shown in **Figure 5**. The concept design provides for separate left and right turn lanes in the Byron Street approach leg. It also proposes to move the hold line forward (with associated extension of painted median) to provide improved sight distance for right turning vehicles. It is anticipated this modified layout will enable relatively free flow for left turning vehicles, reduce queue lengths and delays for right turning vehicles and reduce driver frustration.

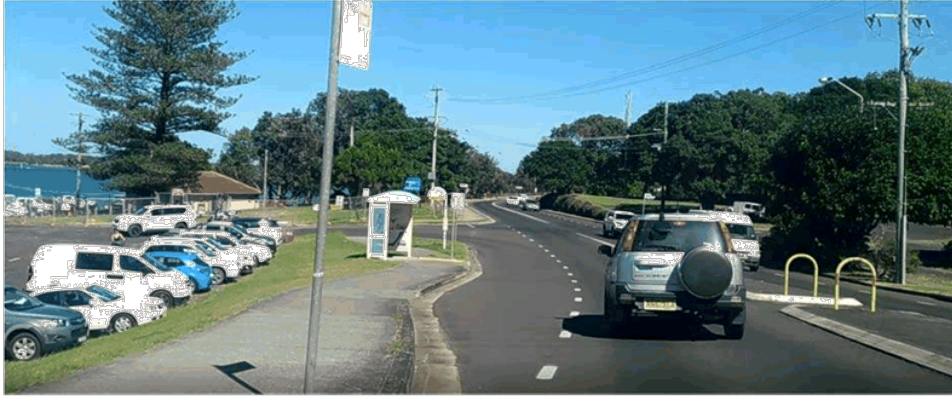
<p>1.2 Shared bus zone and left turn lane The bus zone on Hill Street between Brighton Street and Compton Drive is also used as the left turn lane from Hill Street into Brighton Street. Vehicles wanting to turn left here while a bus is standing in the bus zone will either need to wait in the Hill Street through lane (potentially resulting in a rear-end collision) or turn in front of the bus (potentially resulting in the bus colliding with the passenger side of the turning vehicle).</p> <p><i>Refer 1.1 for recommendations that will mitigate this risk.</i></p>	Occasional Minor Medium	Yes	As above.

Photo 2 – Hill Street, bus zone and refuge

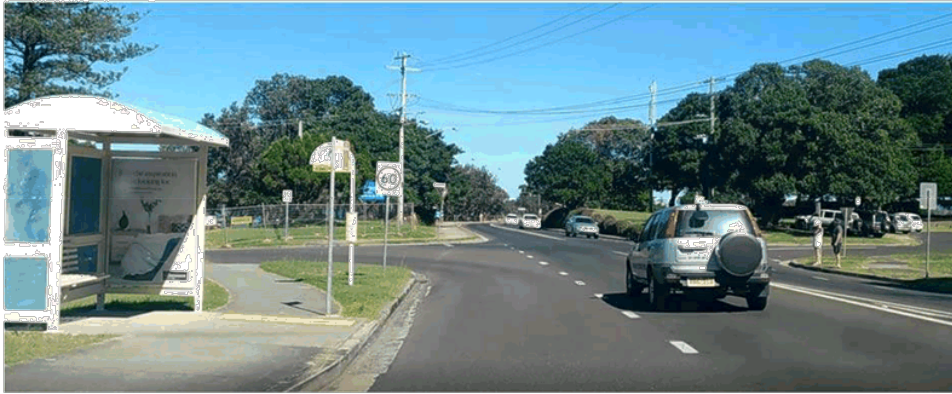
Audit findings	Risk Ranking	Client	
		Accept Yes/No	Comments
<p>1.3 Bus obscuring view for motorists exiting Brighton Street Street A bus stopped in the bus zone on Hill Street between Brighton Street and Compton Drive would obscure the view of westbound traffic on Hill Street for motorists wishing to exit Brighton Street.</p> <p>This may result in a broadside crash between the vehicle leaving Park Street and through-traffic travelling west past the stopped bus.</p> <p><i>Refer 1.1 for recommendations that will mitigate this risk.</i></p>	<p>Improbable Serious</p> <p>Medium</p>	Yes	As above.
<p>1.4 Range Street no through road There are no provisions within Range Street (~75m in length with 9m carriageway width) to allow vehicles to turn around without encroaching on private property (i.e. using one of the driveways to make a three-point turn). It is assumed that garbage collection trucks either reverse in or out of Range Street to collect refuse from the residents' garbage bins.</p> <p>Larger vehicles (garbage/delivery/removalist trucks) unable to make the three-point turn within the space available will be forced to reverse out of the street and there is risk of collision with other vehicles entering Range Street</p>	<p>Improbable Minor</p> <p>Low</p>	Yes	As above.

Photo 3 – Hill Street, bus stop and Brighton Street / Park Street intersection

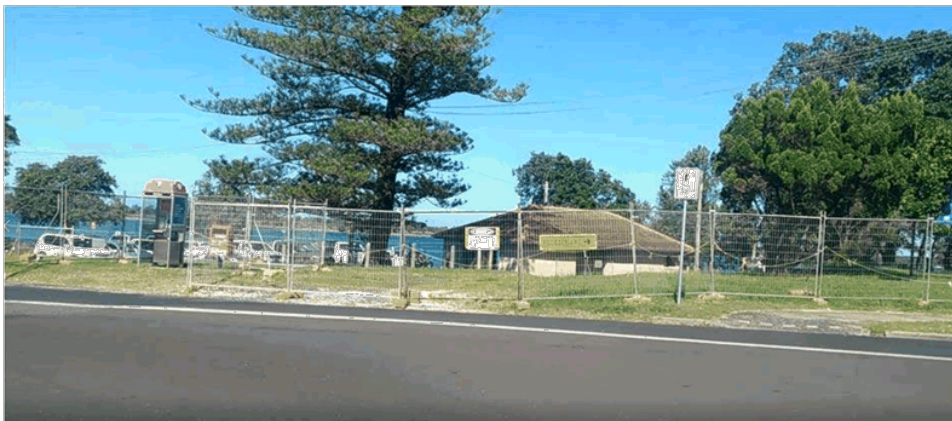
Photo 4 – Brighton Street, fenced area

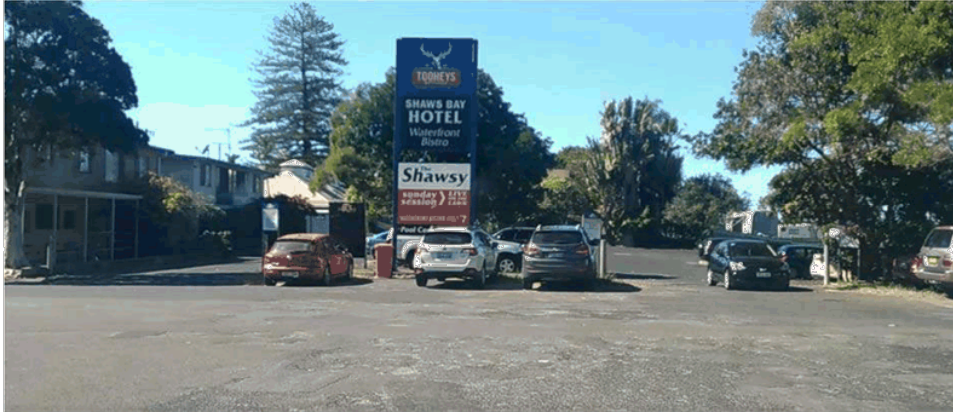
Photo 5 – Brighton Street, entry to Shaws Bay Hotel car park

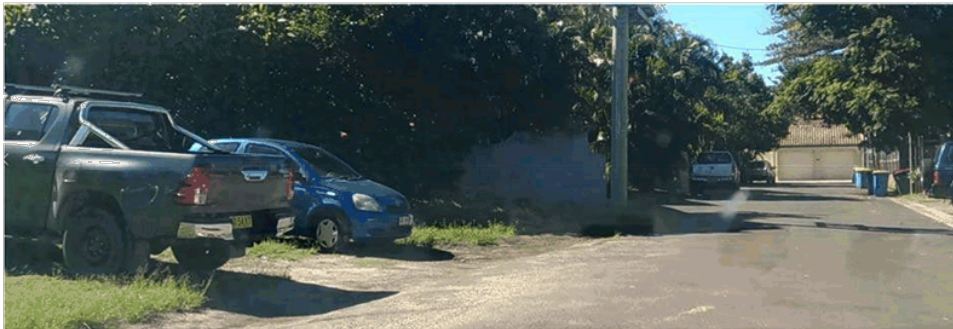
Photo 7 – Range Street, informal parking

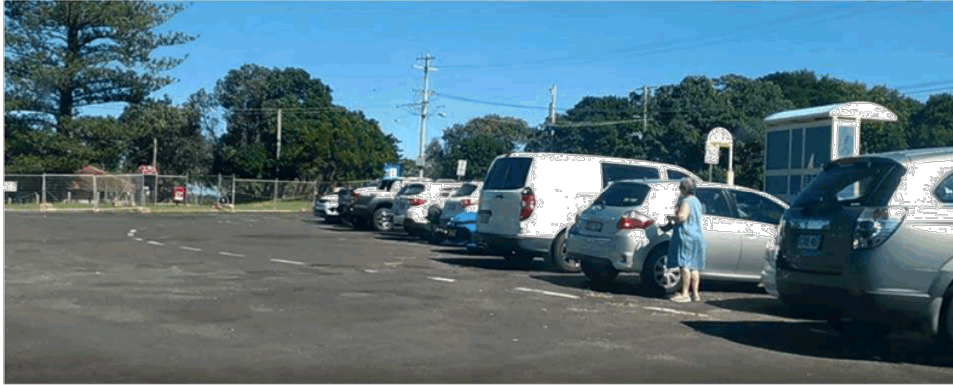
Photo 11 – Brighton Street, semi-formal parking

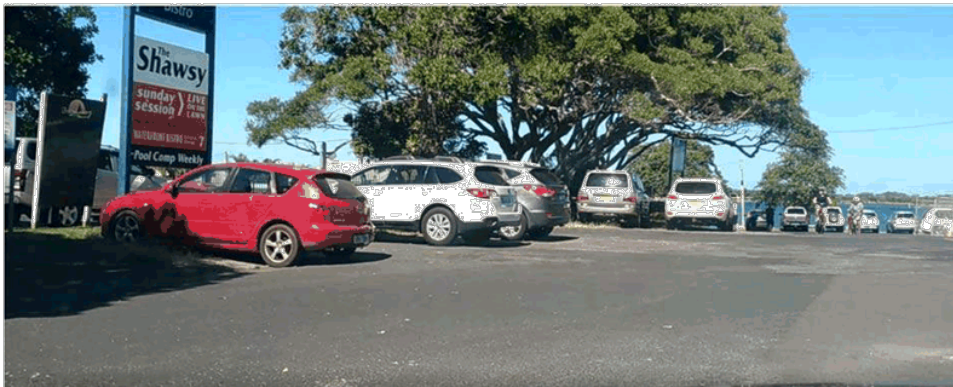
Photo 13 – Brighton Street, informal parking

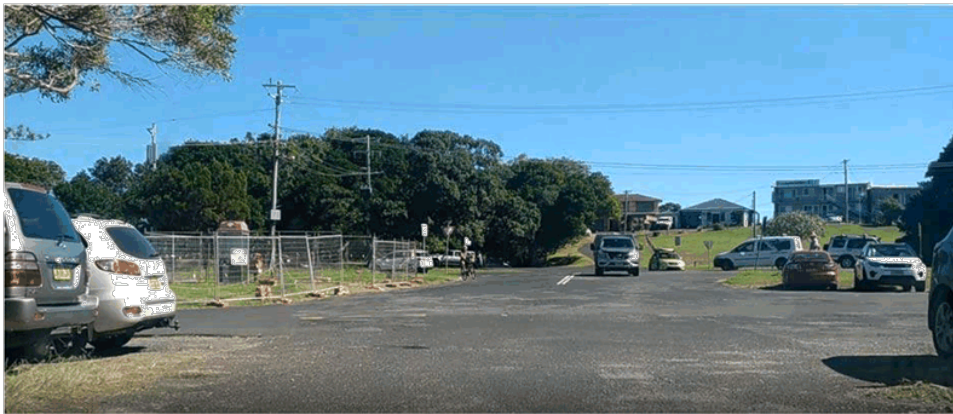
Photo 15 – Interface of Shaws Bay Hotel car park and Brighton Street

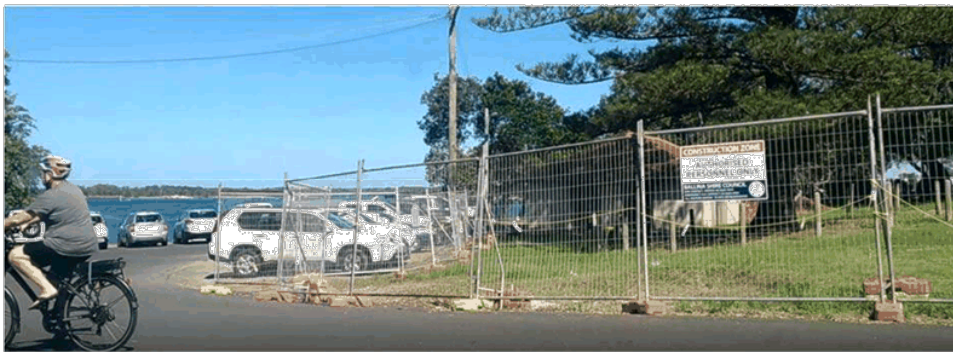
Photo 16 – Intersection of Brighton Street, fenced area

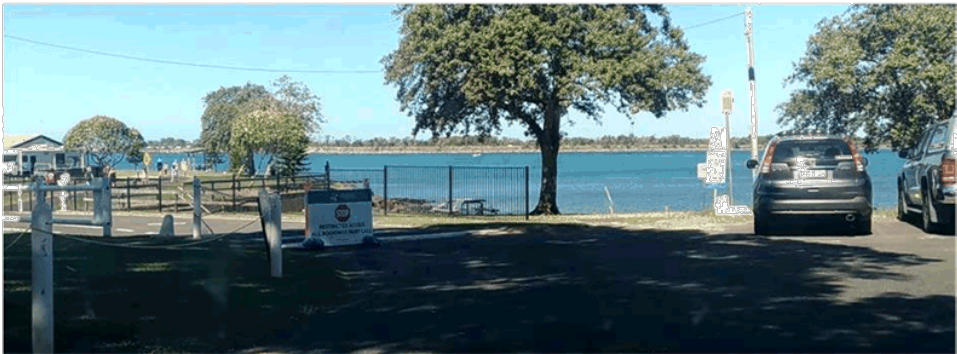
Photo 18 – Brighton Street, entry to Reflections Holiday Park

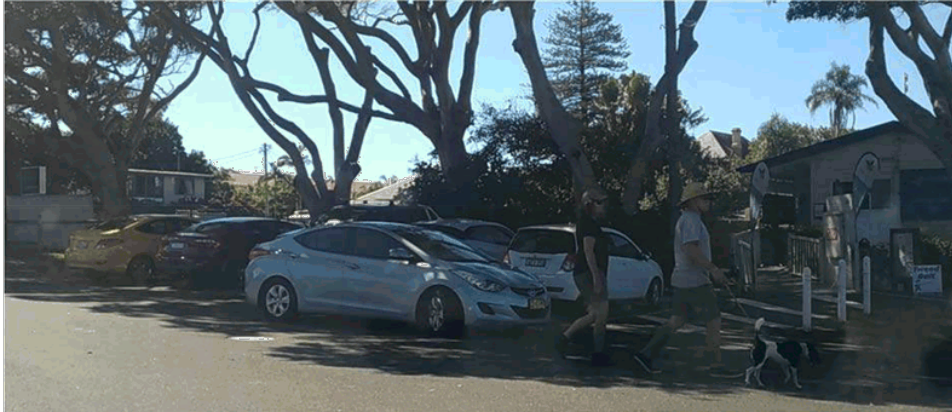
Photo 20 – Informal parking fronting Reflections Holiday Park

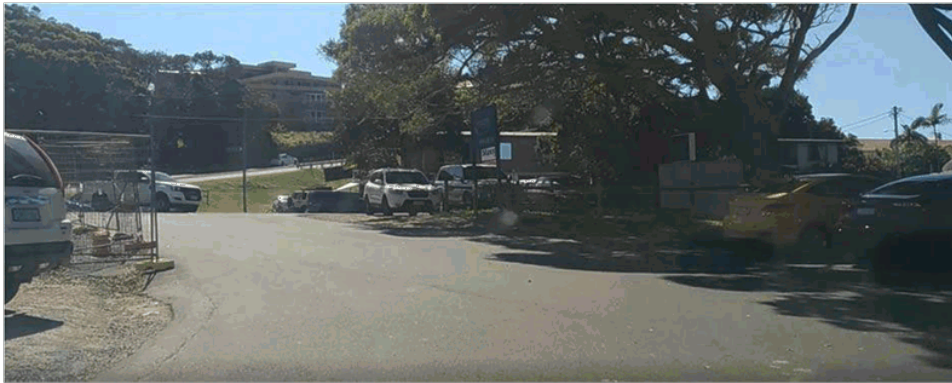
Photo 21 – Brighton Street

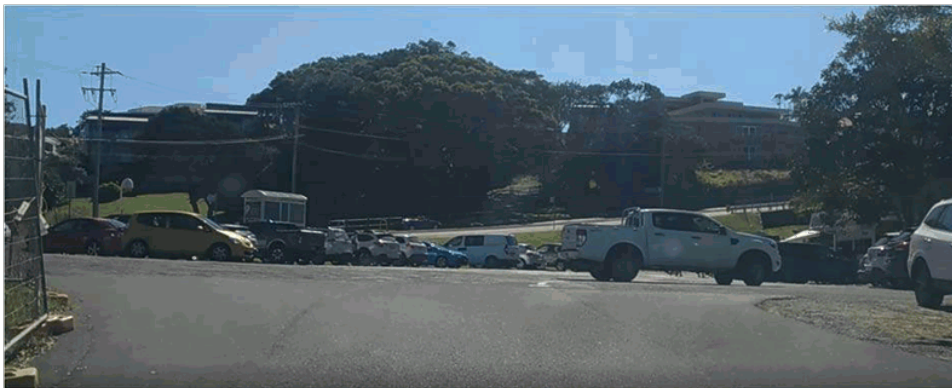
<p>1.5 Intersection of Brighton Street (east-west) and Brighton Street (north-south) In plan view, the geometry of this 'intersection' suggests that the two sections of Brighton Street join with a tee-intersection. However, the linemarking, lack of give-way (or similar) signage and ill-defined edges create a space of confusion, with motorists clearly unsure which movements have right-of-way. This area was observed to operate on an ad-hoc basic, with motorists using eye-contact and hand signals to determine who would proceed with competing movements. During peak times, this area is well known to be chaotic and disorganised.</p> <p>Confusion within a roadway, even at low speeds creates a risk of collisions between motorists who perceive the environment in different ways.</p> <p>It is recommended that this intersection be formalised, including appropriate signage, linemarking and edge restraints (<i>refer audit finding 1.1</i>).</p>	<p>Probable Minor</p> <p>High</p>	Yes	As above.

Photo 22 – Intersection of Brighton Street (east-west) and Brighton Street (north-south)

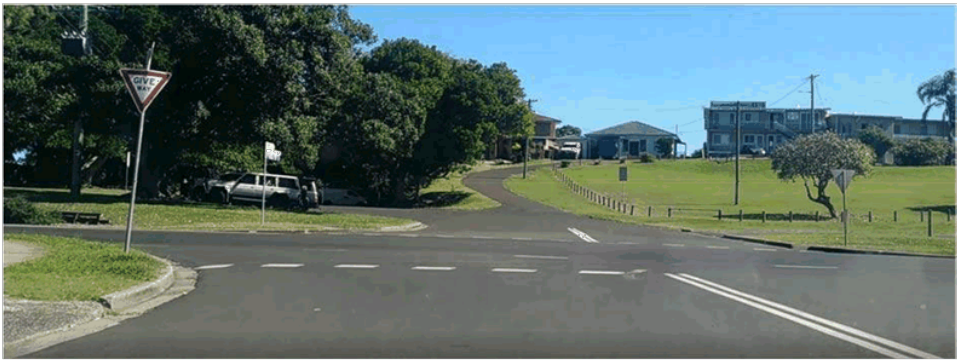
Photo 24 – Intersection of Brighton Street and Hill Street

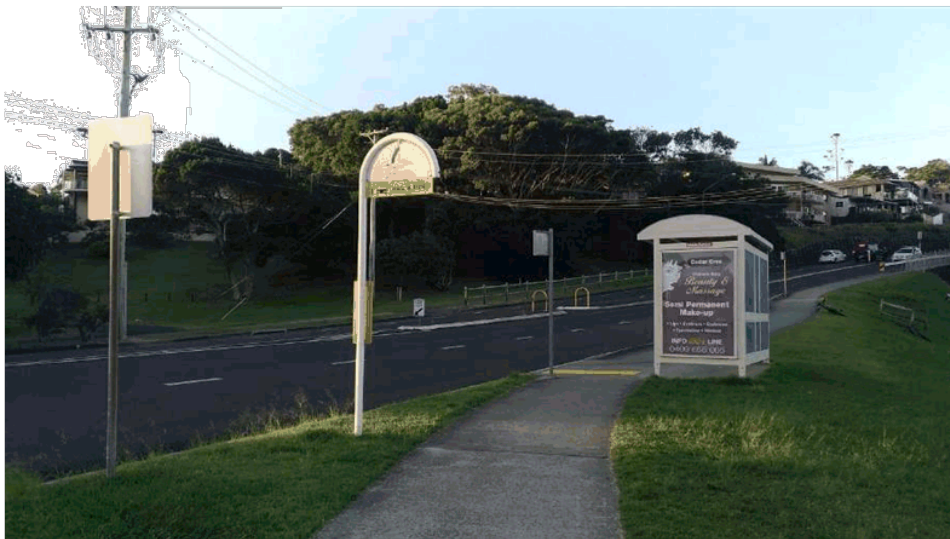
Photo 25 – Hill Street, bus stop and refuge

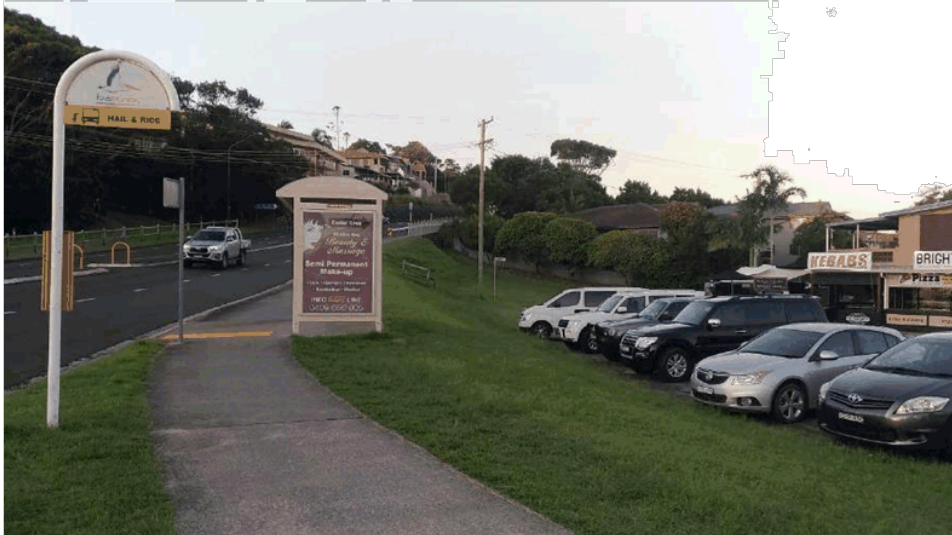
Photo 26(a) – Hill Street, bus stop, Brighton Street informal parking

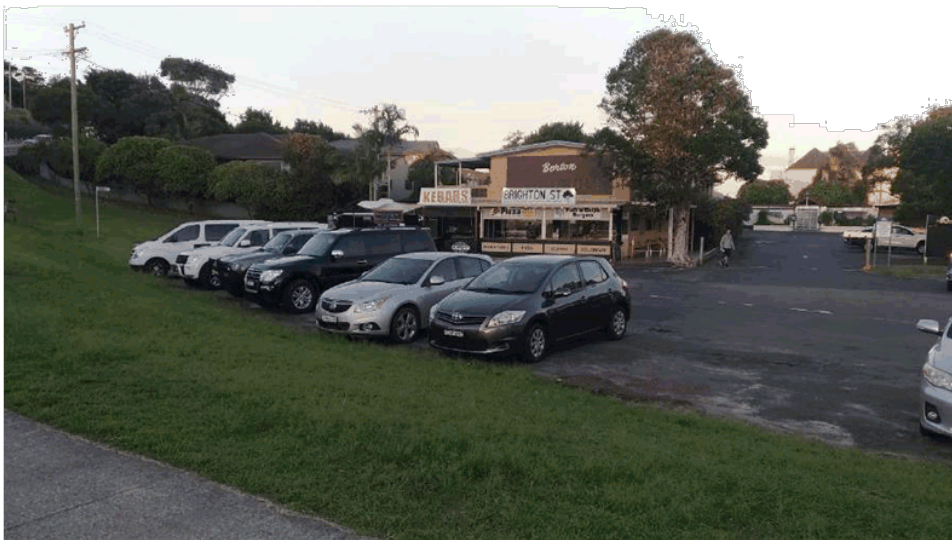
Photo 26(b) – Brighton Street, information parking and take away food shops

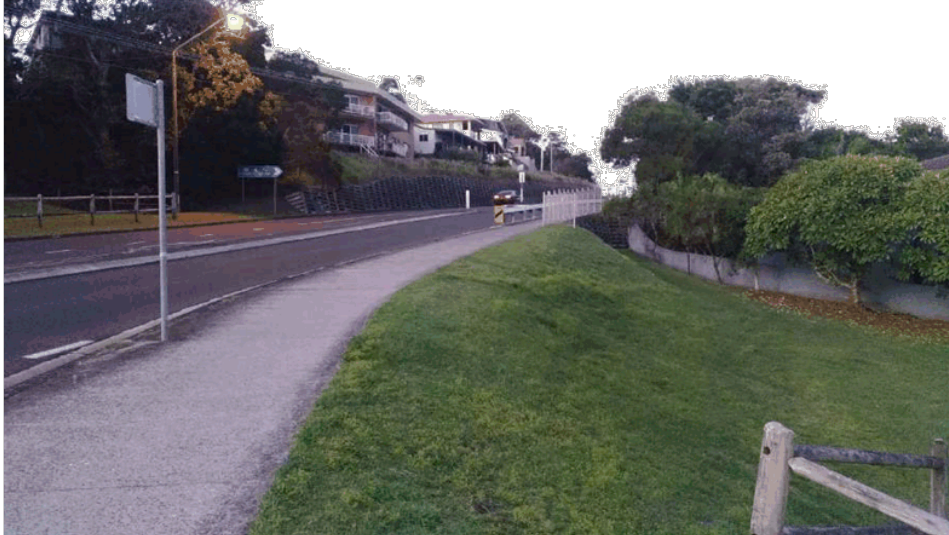
Photo 29(b) – Hill Street, shared path

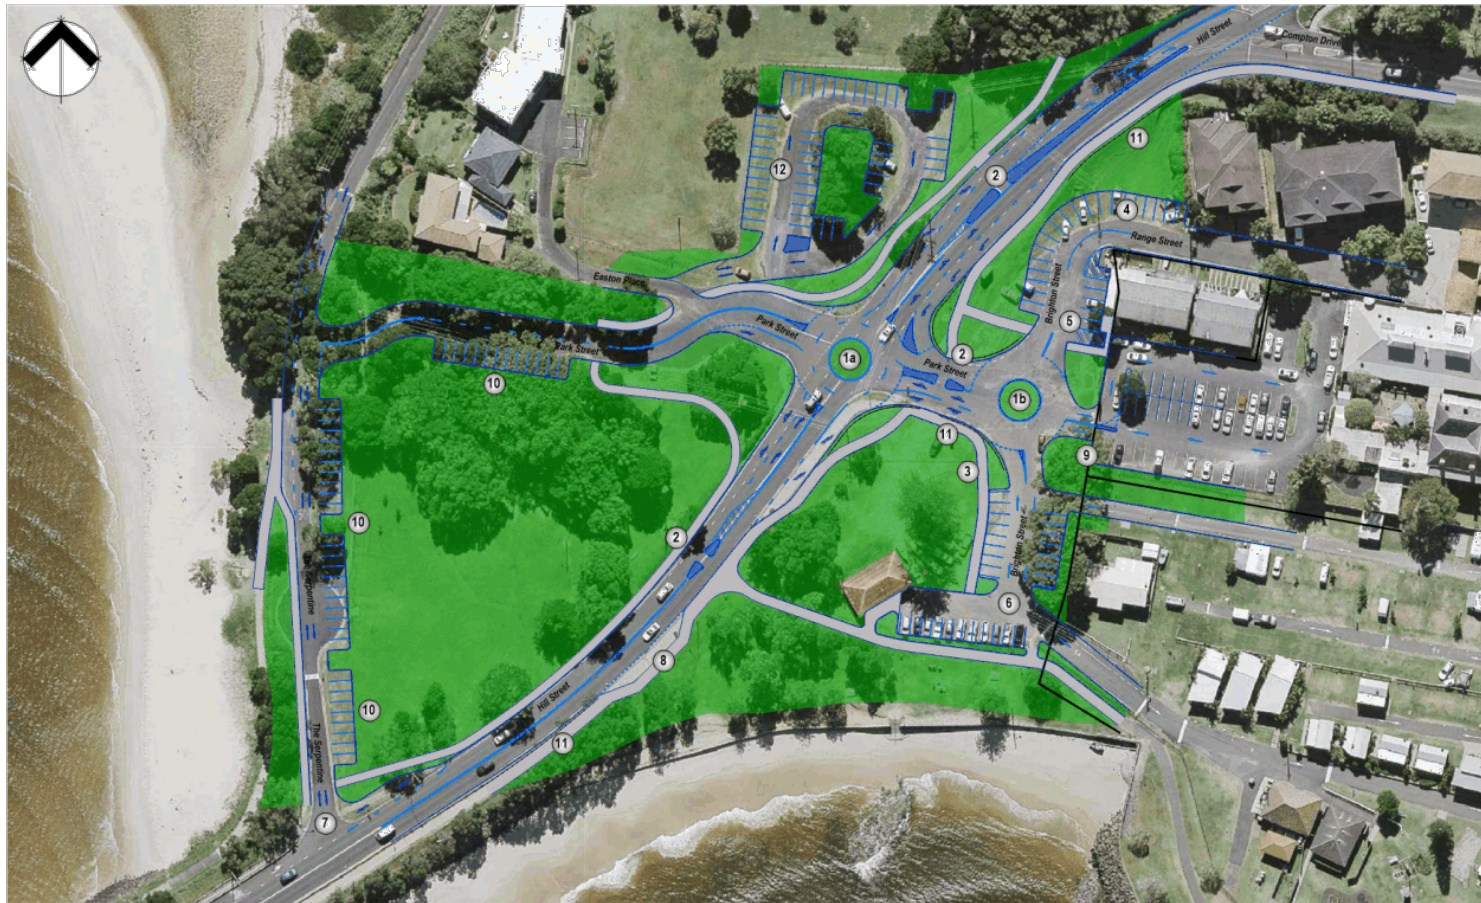
11. Barrier fencing to prevent pedestrians/cyclists from crossing roads in hazardous locations or falling down embankment.
12. Prevent parking in this area using bollards.
