# ADDENDUM to the Richmond River Estuary Processes Study

For Richmond River County Council

PROJECT NUMBER: BB074

11/05/2009

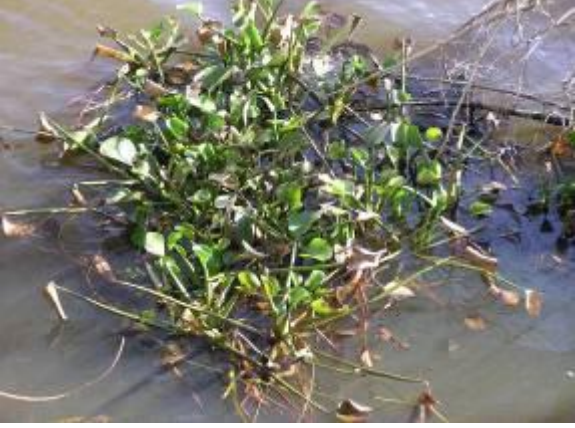
Figure : Site BC8 (Northern bank at Wardell).

<p>Transport of water hyacinth during flood events occurs in the Richmond River.</p>	<p>Erosion control at Wardell</p>

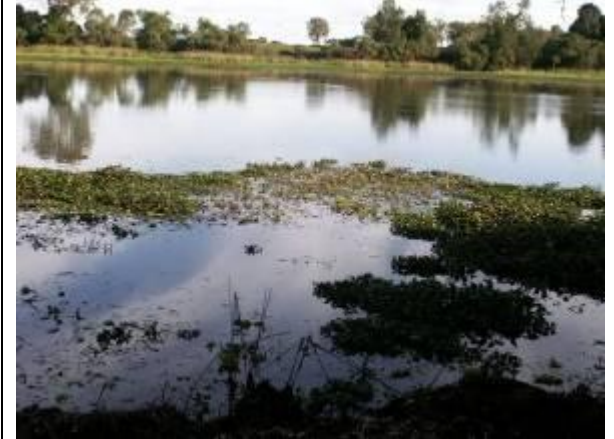
Figure : Images from site SB20

<p>Wetland habitat with some weed aquatic weed issues</p>	<p>Mixed species of aquatic plants</p>

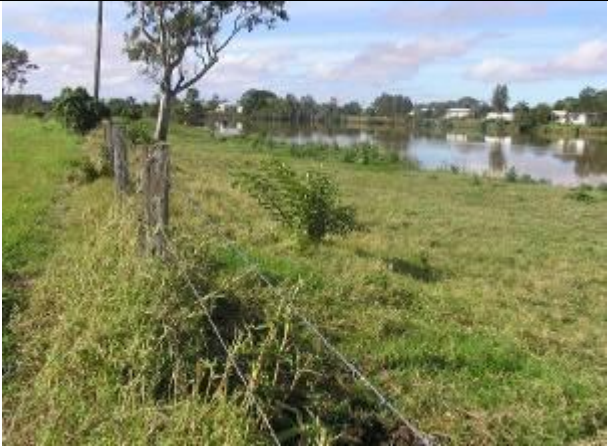
<p>Google image of this site</p>	<p>Extensive grazed riparian area note coral tree</p>

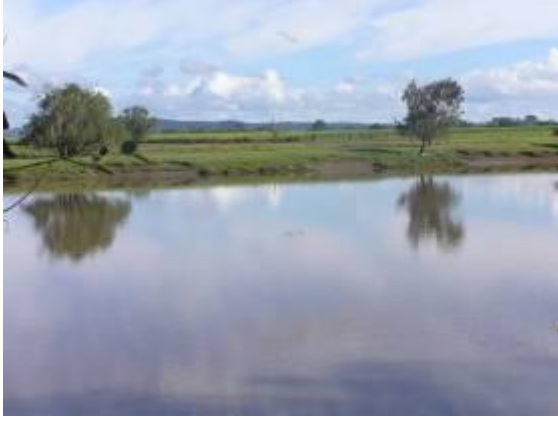
<p>Google image of this site</p>	<p>Bank slumping on opposite bank</p>

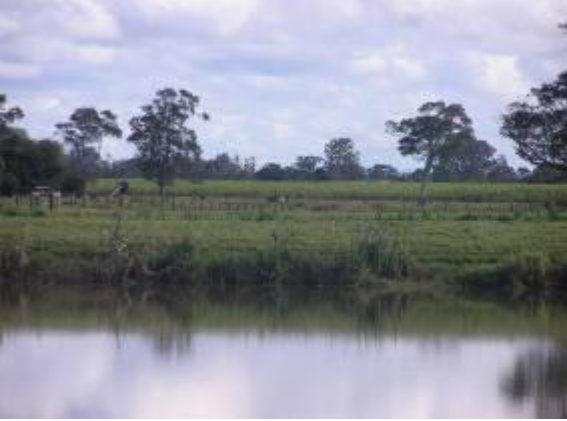
<p>Limited riparian vegetation at this site (opposite Bank)</p>	<p>Floating weeds and sparse riparian vegetation</p>

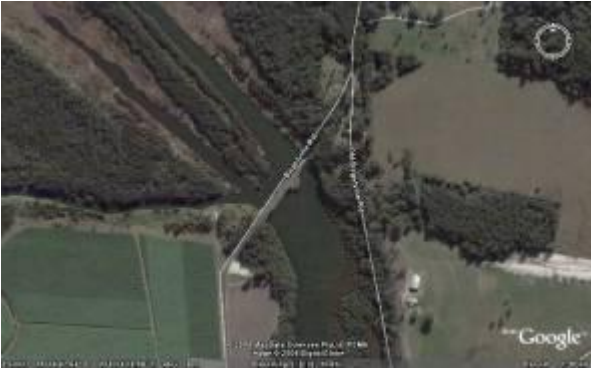
Figure : Images from site T12

<p>Google image of the site</p>	<p>Rocky outcrop on the northern side of the barrage inhibits immediate erosion. Downstream erosion is notable (background)</p>

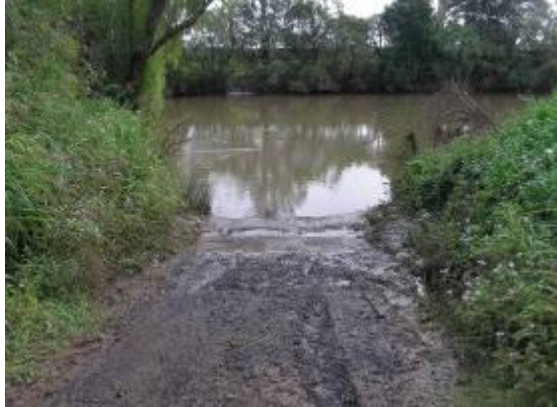
<p>Wyrallah boat ramp</p>	<p>Large area of exposed bank at the Wyrallah boat ramp</p>

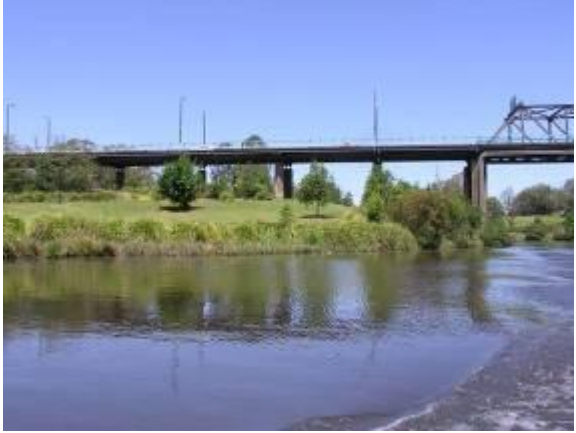
<p>An interesting wetland site occurs near site 24.</p>	<p>Foreshore works in Lismore has been conducted as part of the levee construction.</p>

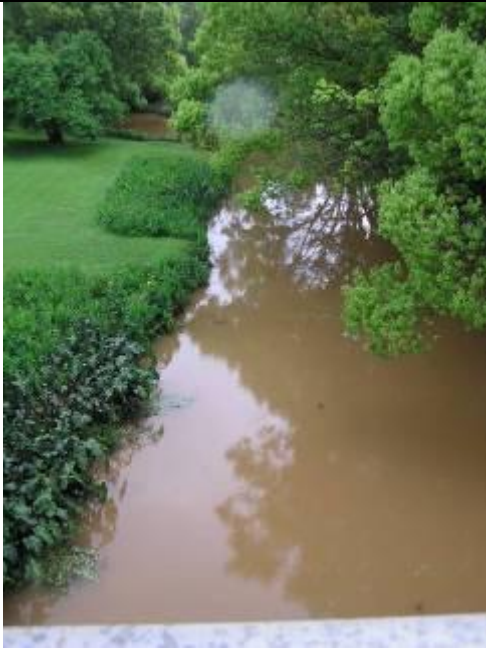
<p>Jabiru Geneebeinga wetlands are near Casino. Opportunities exists to protect further wetland refuge areas.</p>	<p>Turbidity is compromised during rainfall events in the Wilsons Creek at Bangalow, far upstream from the study area.</p>

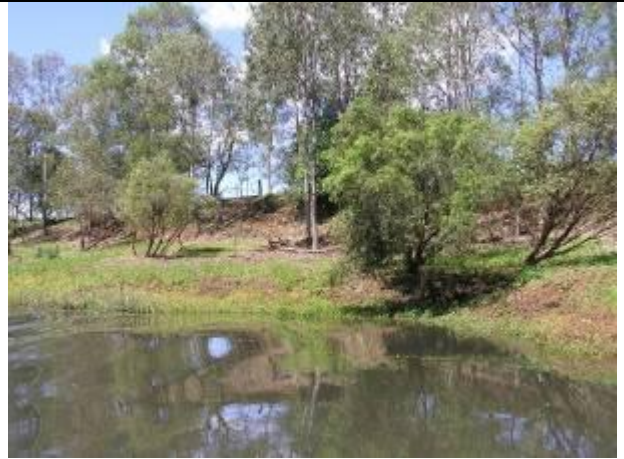
Cattle fencing and riparian revegetation on the Wilsons River.

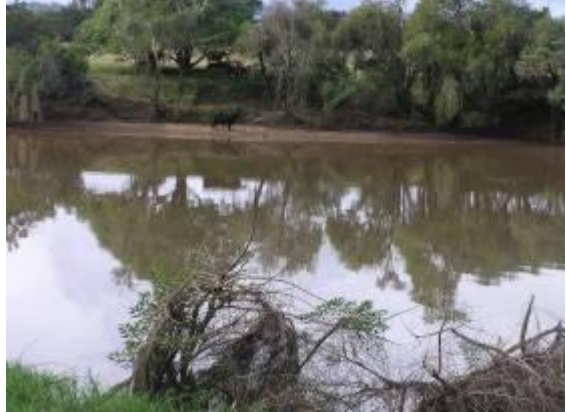
<p>A google image of the site</p>	<p>Cattle access to the river on opposite bank at Coraki</p>

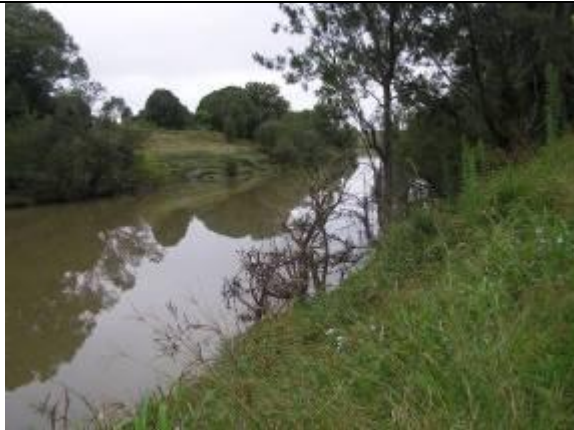
Some weed management would benefit this site.

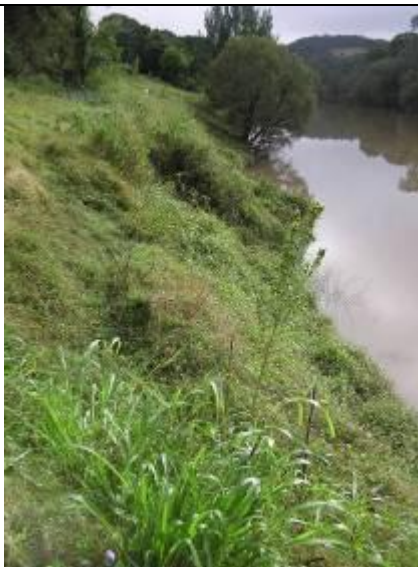
Willing landowner at this site provide possible

further riparian management. Upstream of site

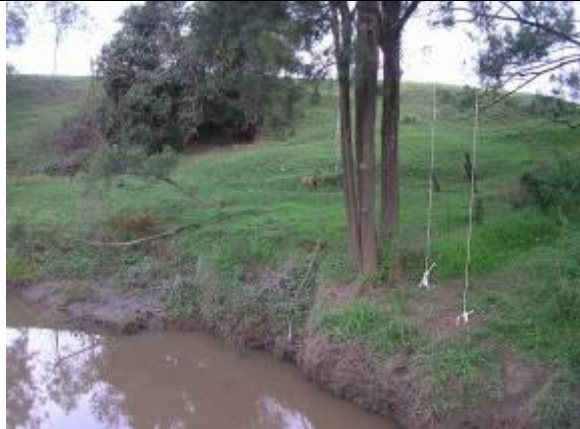
<p>Upstream of the bridge</p>	<p>The swing ropes indicate that primary contract recreation occurs at this site.</p>

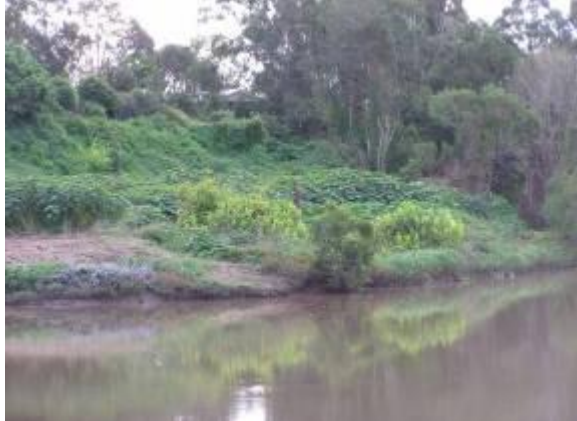
<p>Weed issues at this site</p>	<p>Opportunities for riparian vegetation enhancement.</p>
